Restoration of the 8 chörten building

Wanla, Ladakh, India

Achi Association India

11 October 2014

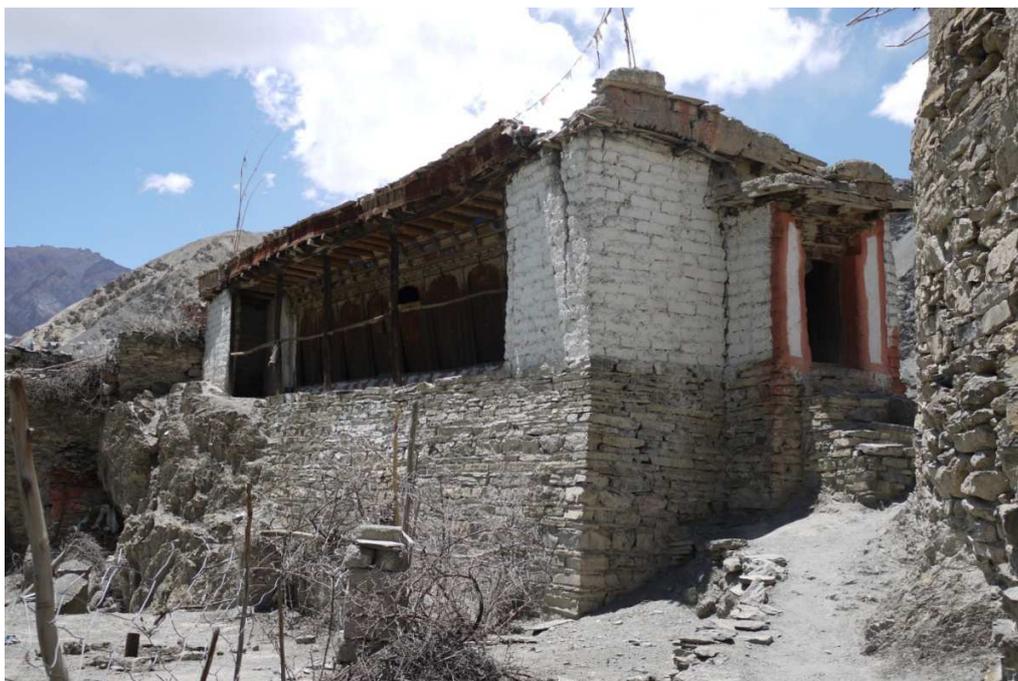
Fig. 9: Condition of the 8 chörten building at the start of the campaign 2014 (photo: Hilde Vets)

In comparison with the survey of 2013 the overall condition of the building had severely worsened.

The cracks in the walls had widened and some more cracks had appeared, endangering the stability of the whole building. Especially the walls of the outer structure near the entrance were in a very bad condition and were separating at corners. But also in the east wall of the inner structure (opposite the entrance) two huge cracks (2-5 cm width) cut through the entire adobe bricks, affecting as well the wall paintings on the inner side.

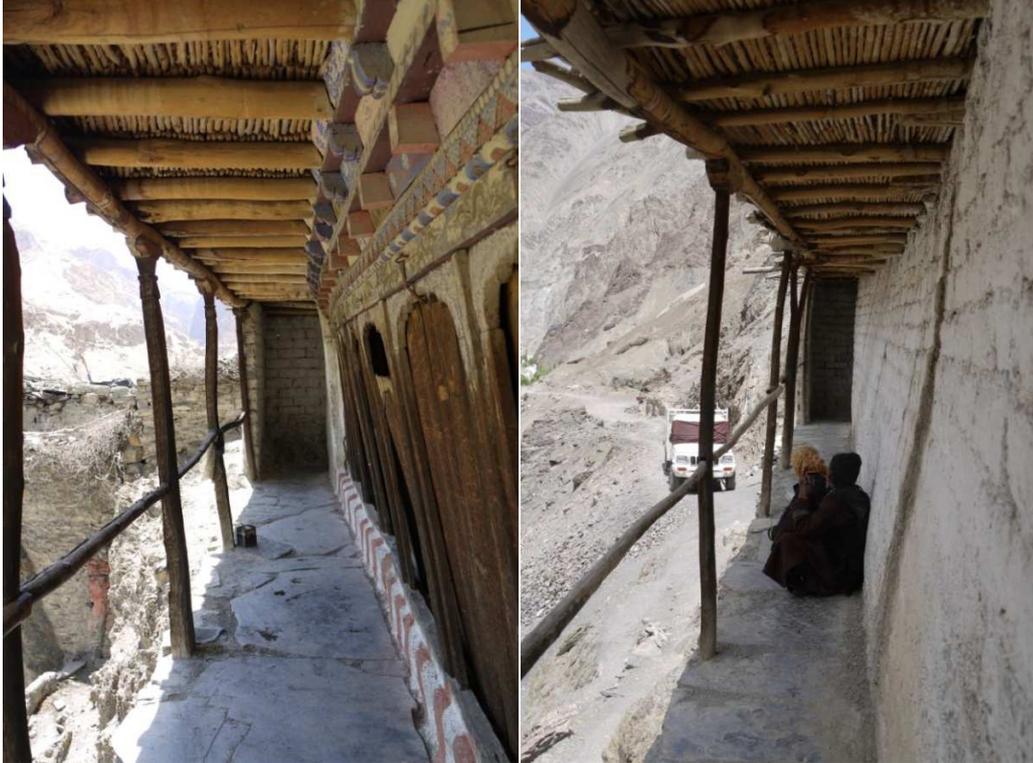
Fig. 10-11: Condition of the 8 chörten building: the circumambulation (photos: Hilde Vets)

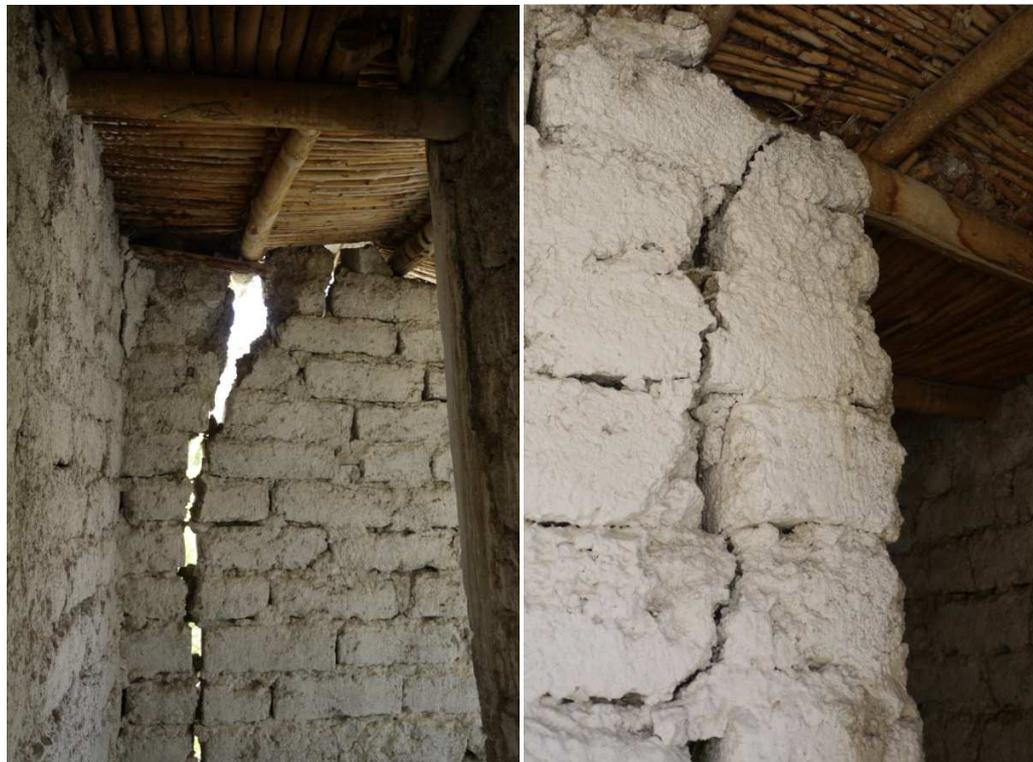
Fig. 12-13: Condition of the 8 chörten building: the circumambulation - details (photos: Hilde Vets)

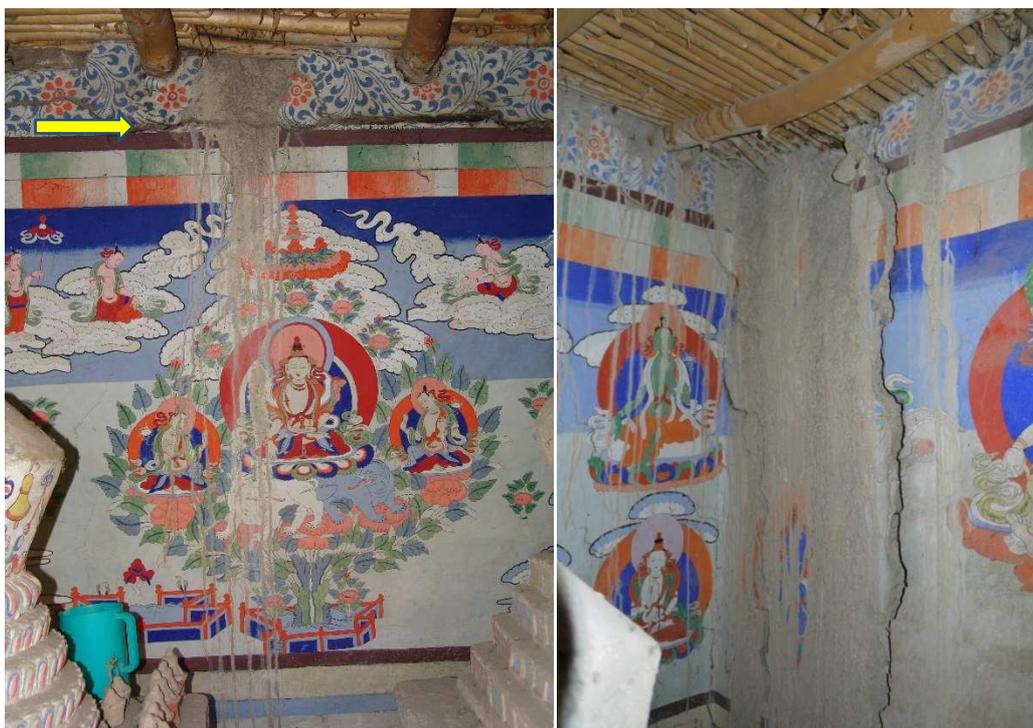
The paintings were well preserved, the colours still vivid. However they show some severe damages due to the poor state of the buildings' structure. As the heavy roof load pushed on the supporting walls, vertical cracks appeared. The walls were bulging out, went into strong deformation causing horizontal cracks (mainly underneath the beams/floral designs).

Leaks of the roof led to water penetration, mud runners and loss of plaster. Most strongly affected were the east and west ends of the inner structure, where water had come in with devastating effects.

Fig. 18: Leaks of the roof led to water penetration and loss of plaster. Underneath the beams the big horizontal crack (yellow arrow) caused by the movement of the wall (photo: Anne Voll)

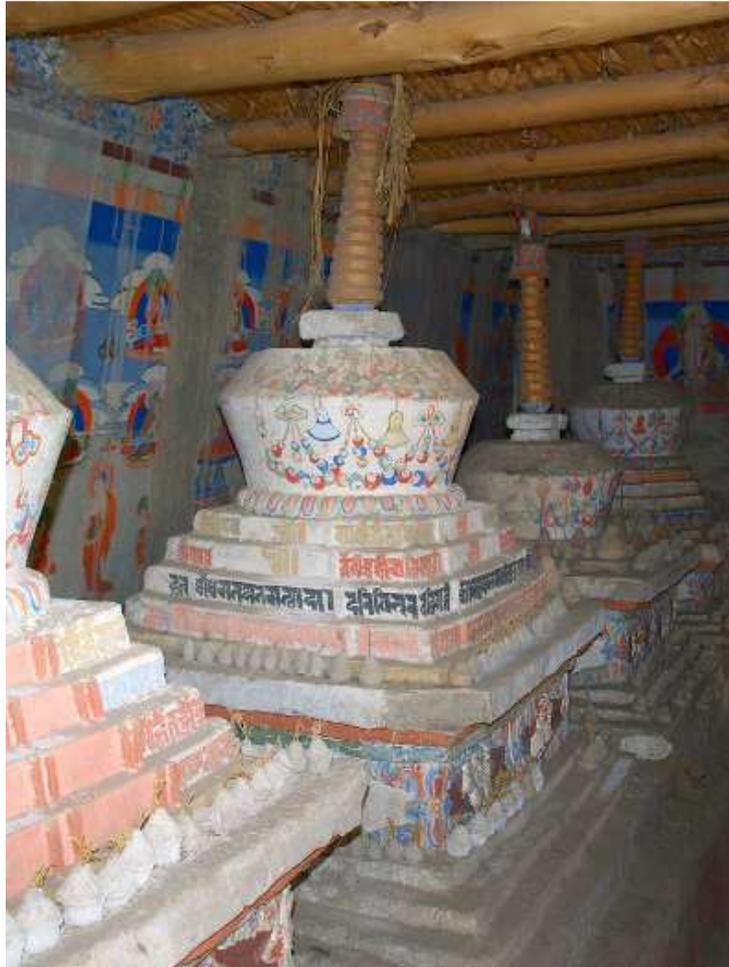
Fig. 20: Chörten no. 3 (before restoration). Broken corners and dust as well as a hunched staff. Height from floor level to top: ca. 210 cm. (photo: Anne Voll)

A lot of corners and edges had cracks, were broken off or even lost.

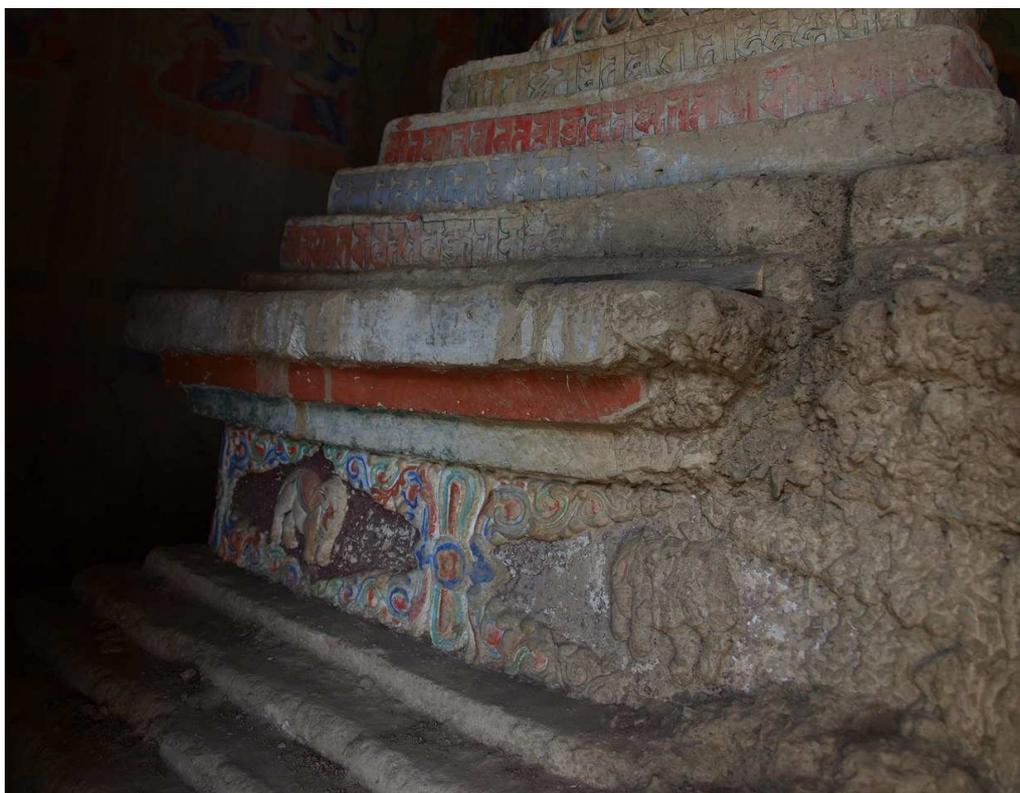
Water damage occurred due to leaks in the roof resulting in washed off parts combined with mud runners. Especially at the outer two chörten, only one of the two figures had survived.

Fig. 21: Base of chörten n° 8: Only one of the white elephants survived. The right corner was completely washed away. (photo: Anne Voll)

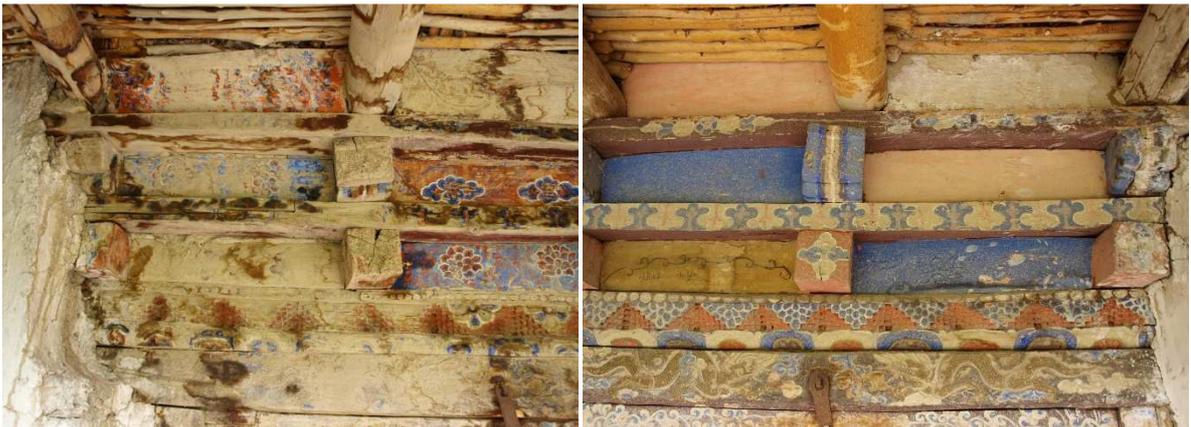
Fig. 25 : Left end of the screen: the paint layer washed out. Water stains and a thin mud layer obscure the image. (photo: Anne Voll)

Fig. 26 : Right end of the screen: white paint drops have splashed on the decorated elements. Also visible cracks have appeared at the connection with the plastered wall as well as in the profiled wooden blocks (*pag-sna*) due to the mechanical stress. You can also notice sketches on one board and plain monochrome colour boards. (photo: Anne Voll)

Apart from this, the main problem was the area at the southwest end of the window: as water was able to come in through cracks in the roof, it resulted in washing away the decoration of wooden panels and window frame. It seemed to have entered over a longer period of time, leaving behind an obscured image of the former decoration. Water stains and a thin mud film remained.

Furthermore, with the heavy roof load leaning on the screen, the paint layer had suffered from mechanical stress and cracked, together with its wooden support.

To prepare the window for the coming work and as an emergency measure, the screens' paint layer was consolidated. Loose paint layer was treated with injections of fish glue (appr. 5% in water). Where the paint layer had cracked up, the fish glue was applied through Japanese paper with a soft brush. To help reattaching the paint layer to the wood, it was pressed gently with non-sticking plastic foil.

As the screen also had to be propped, the paint layer was secured with a double layer of Japanese paper against the mechanical stress. The paper was glued reversibly with Klucel E in water. Additionally, a soft padding was applied between props and underground. As soon as the roof was exposed, the screen was covered with plastic sheets.

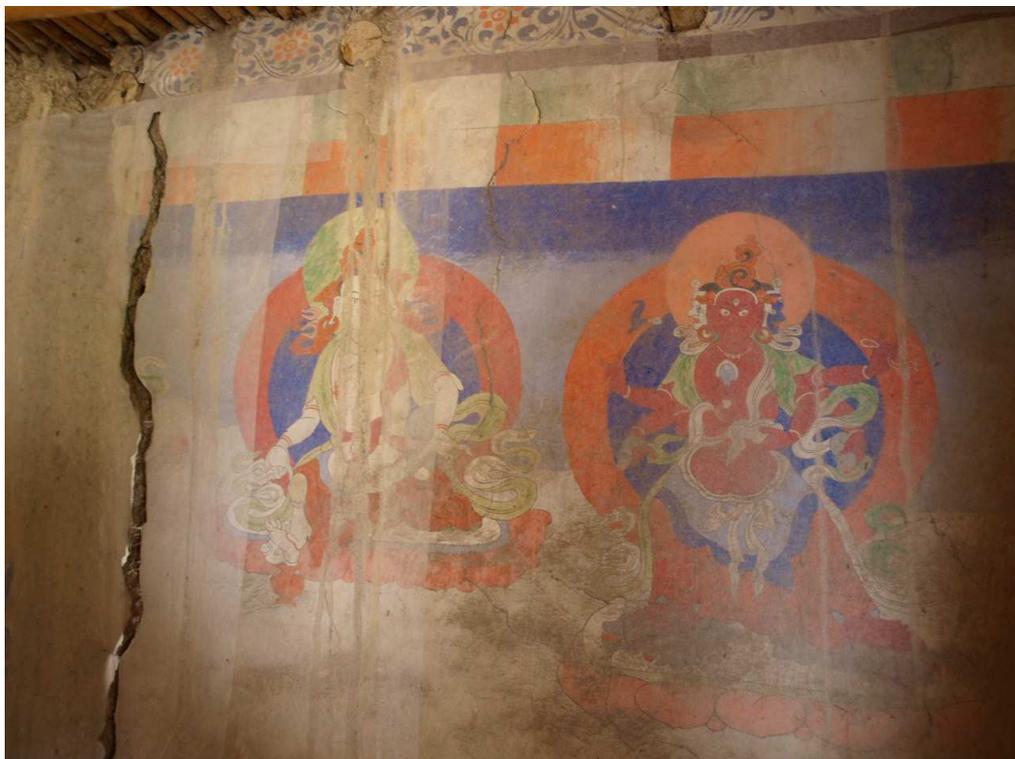
Fig. 27 : Two layers of Japanese paper on the painted wall (east) with the crack in the corner (photo: Anne Voll)

During the campaign of 2013 tests were made how to protect the paintings before propping the leaning wall. The paintings seemed to be carried out with water colours as the binding is not too strong. To protect them from mechanical damage, layers of Japanese paper had to be applied to the surface. The glue for that measure had to be rather weak, but strong enough to keep the paper in place, and in any case reversible.

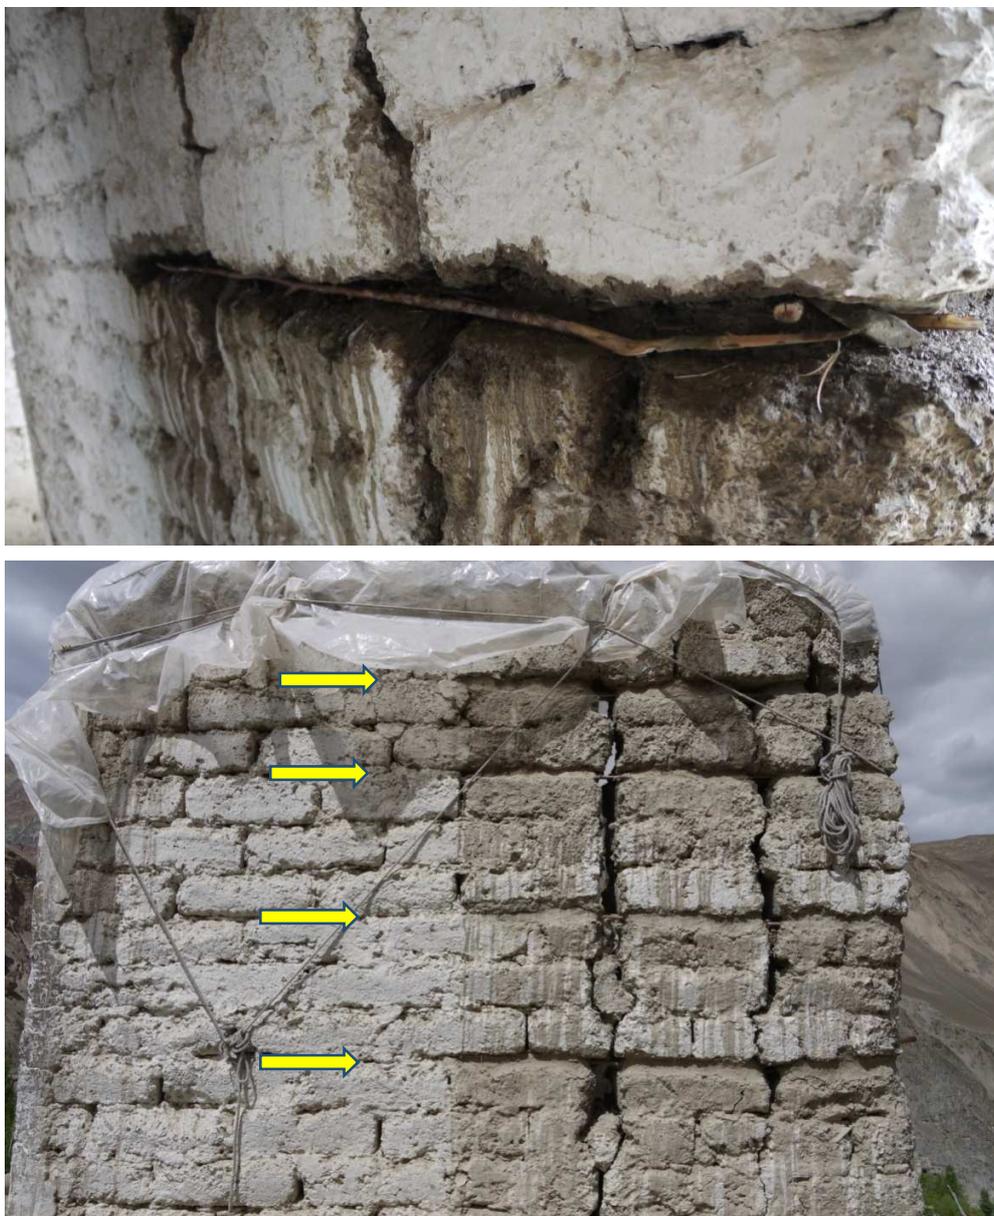
In the east wall of the inner structure (opposite the entrance) two huge cracks (2-5 cm width) cut through the entire adobe bricks, affecting as well the wall paintings on the inner side. The adjoining south wall – weakened and half reduced by leaks through the roof - was leaning outwards, worsening these cracks by the movement.

Fig. 31-32: Reinforcement of the eastern wall by willow twigs (photos: Hilde Vets)

Later on the big voids of the cracks were filled with jute bags soaked in mud mortar. Once these had hardened, the rest of the voids were filled up with a mud mortar (earth, sieved river sand, straw) on the outer side of the wall. The cracks on the painted side were treated by the conservators during the second campaign (see paragraph 2.7.1).

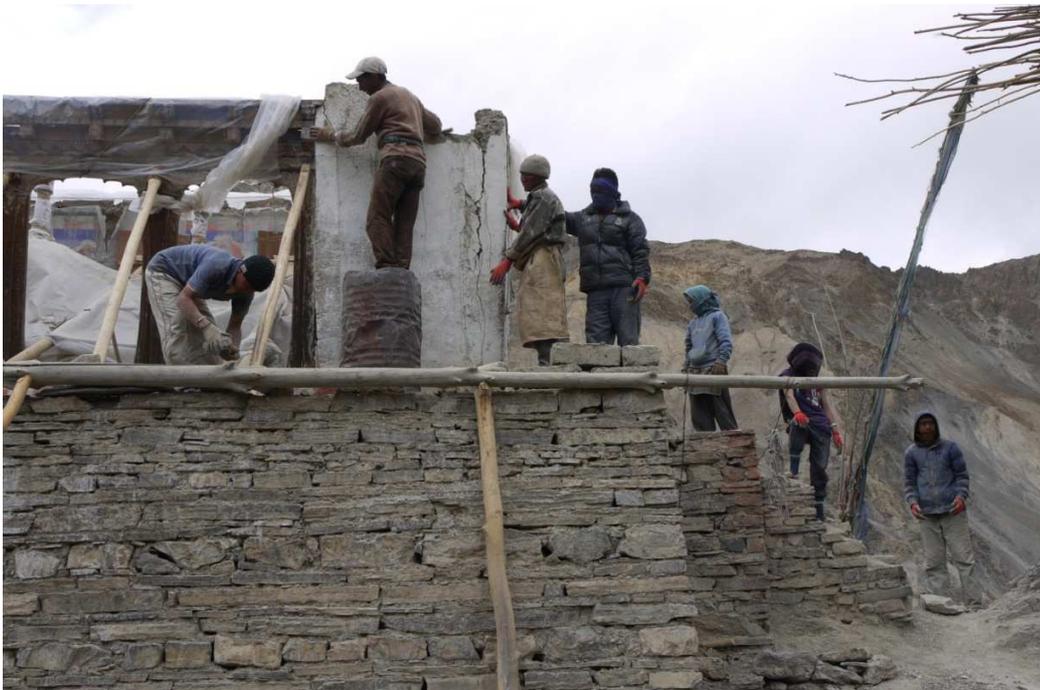
The entire wooden screen was leaning very much outwards (idem inclining wall), also at its ends. This affected the short walls right and left of the screen. Certainly the right wall – being washed out at the inside and separating from the adjoining wall – was leaning badly and a lot of cracks had appeared.

Fig. 44: Breaking down the wall right of the screen to be able to straighten it. (photo: Hilde Vets)

We decided to take down a part of this wall and buttress to 6 rows above the ground level – the height where the crack in the wall, separating the corner, stopped. This way we could straighten the screen and mason it back into the newly built wall.

At the corner, the walls were joined again by removing the half broken bricks and fixing full bricks in the adjoining wall (see fig. 47). The new wall was then plastered on both sides.

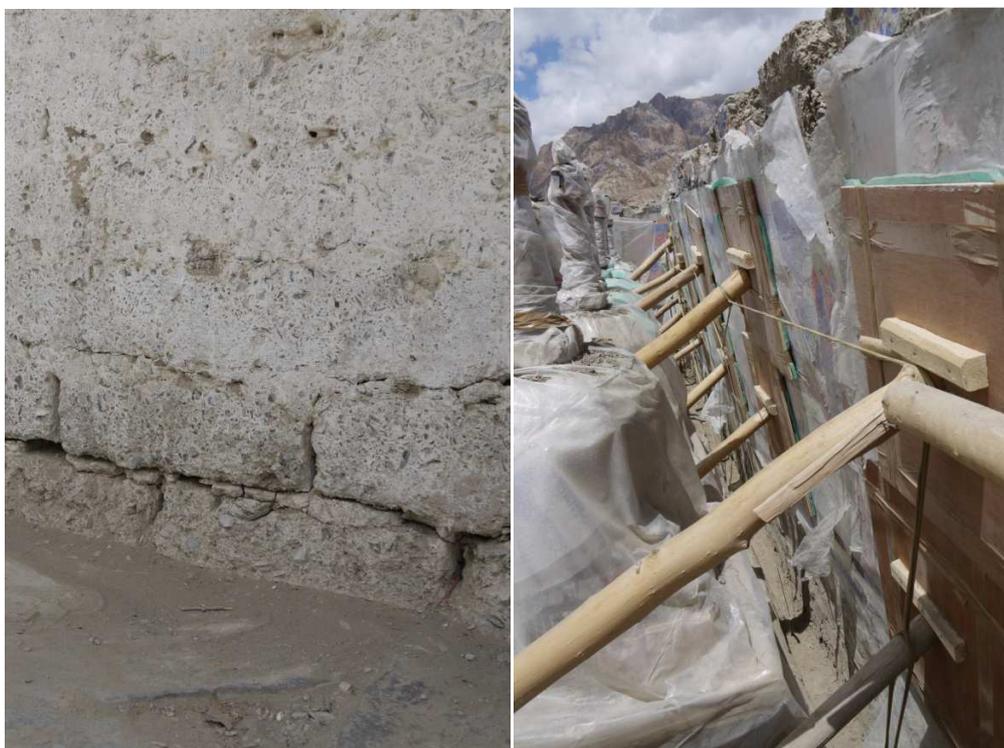
- the rear wall of the inner construction consisted of a single adobe brick of only 20 cm width
- the inclination started at the bottom of the wall, opening two joints, and was fairly distributed over the entire surface of the wall. It went up to the roof joists where as well a big crack (see fig. 18) appeared at the side of the paintings (more or less like a bended 'piece of paper', held on the sides).

- the murals showed only few cracks near the corners, not in the middle part of the wall
- it would surely help the stability of the wall after the restoration. With the current inclination (40,5 cm at most over a height of 230 cm = 10°), the wall would probably need extra support by buttresses to avoid further movement.

Fig. 49: The bottom of the inclined wall with the open joints. (photo: Hilde Vets)

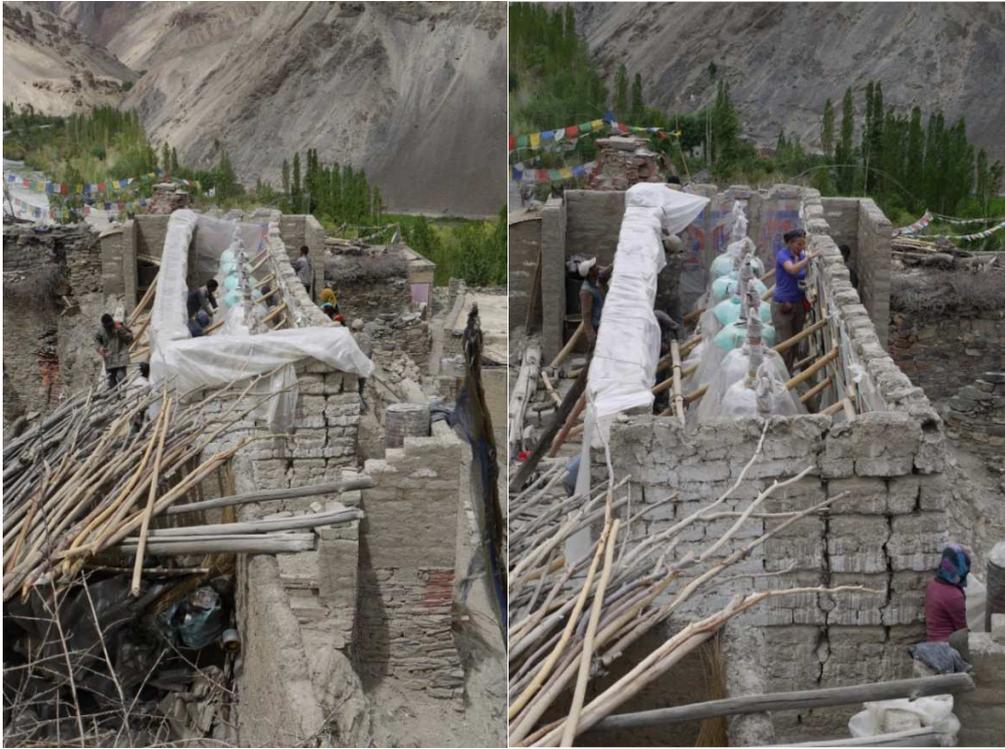
Each trial we managed to move the wall with some centimetres, at the end resulting in 31,5 cm (1'0,5") at the middle of the wall. We decided to stop pushing when the cracks near the northeast corner started to open more. The wall was left inclining about 9 cm at most (in the middle), meaning only half the width of the mud brick.

Fig. 53: Situation before and after the pushing of the painted wall. (photos: Hilde Vets)

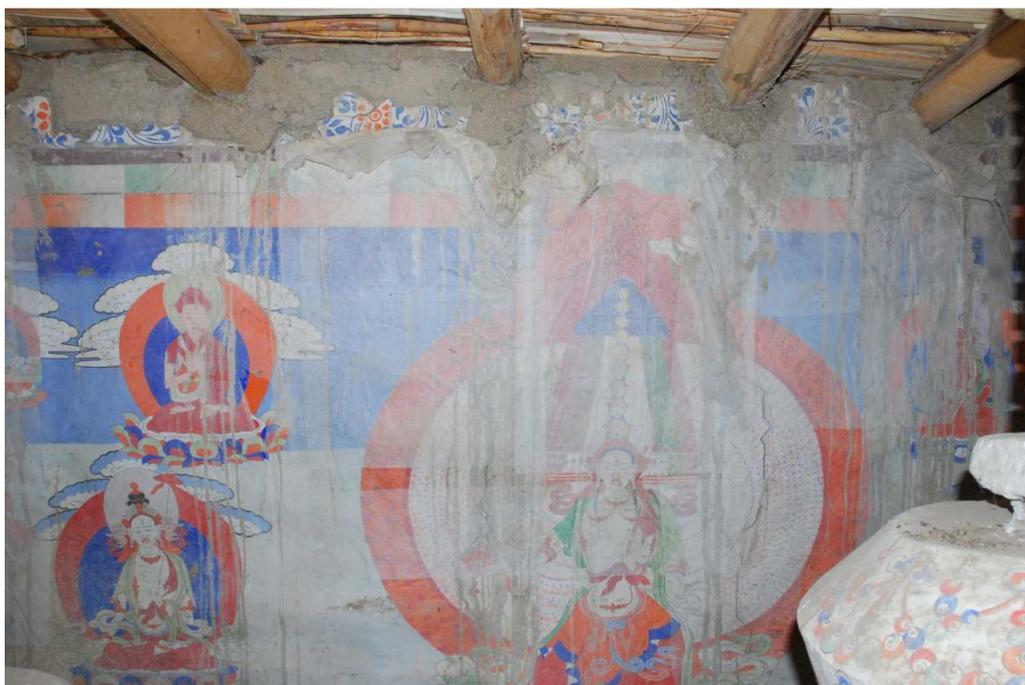
Fig. 82: Condition of the wall after placing of the new roof with the Japanese paper still sticking (photo: Susanne Bosch)

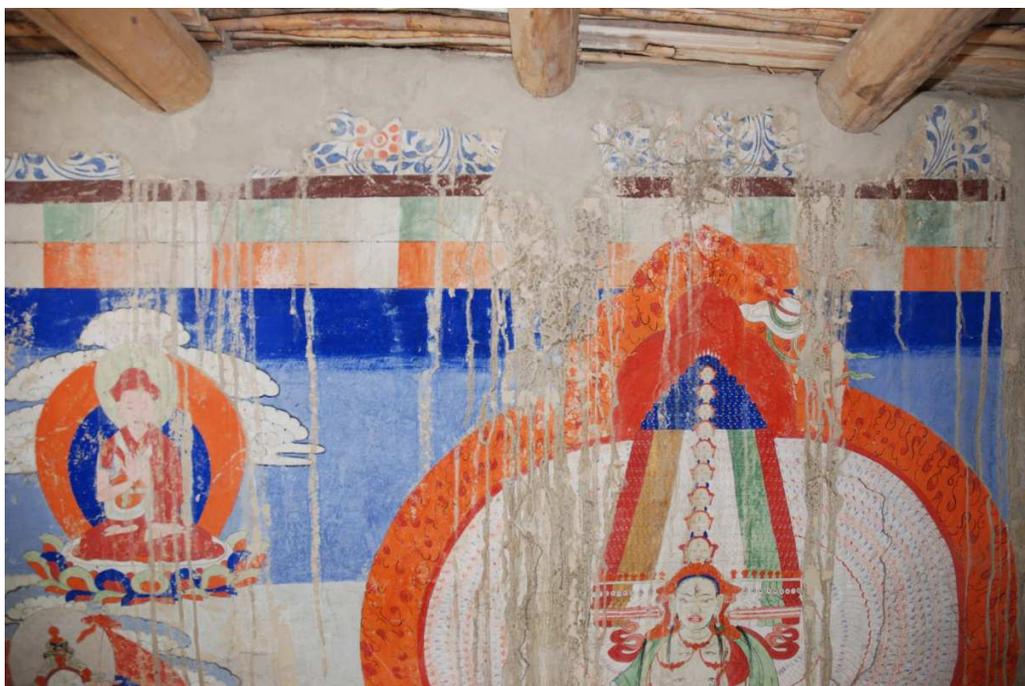
Fig. 83: Condition of the wall after taking off the Japanese paper and after plaster consolidation in the upper area. Mud runners still have to be removed. (photo: Susanne Bosch)

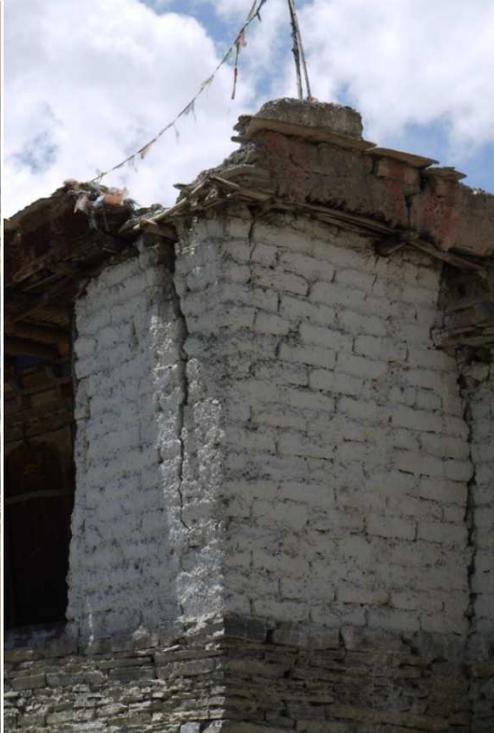
Fig. 92: Condition of the southeast corner. (photo: Hilde Vets)

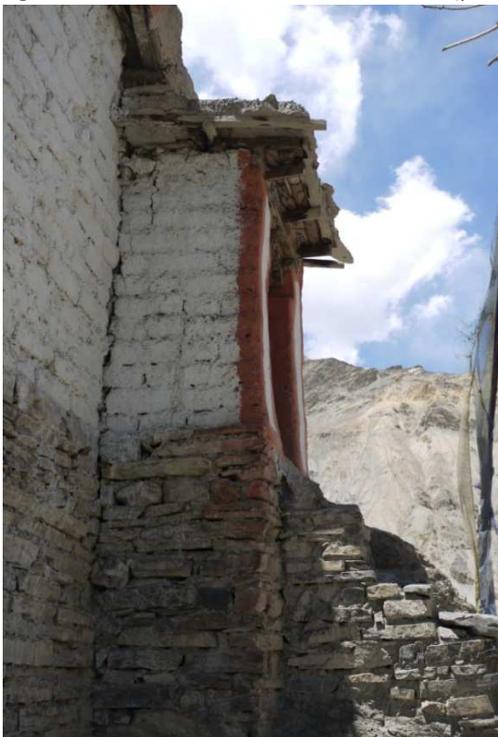
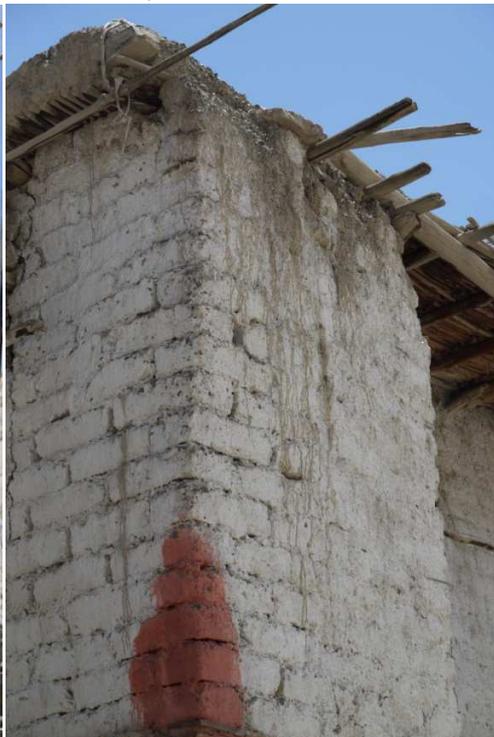
Fig. 93-94: Condition of the entrance and of the northeast corner. (photo: Hilde Vets)

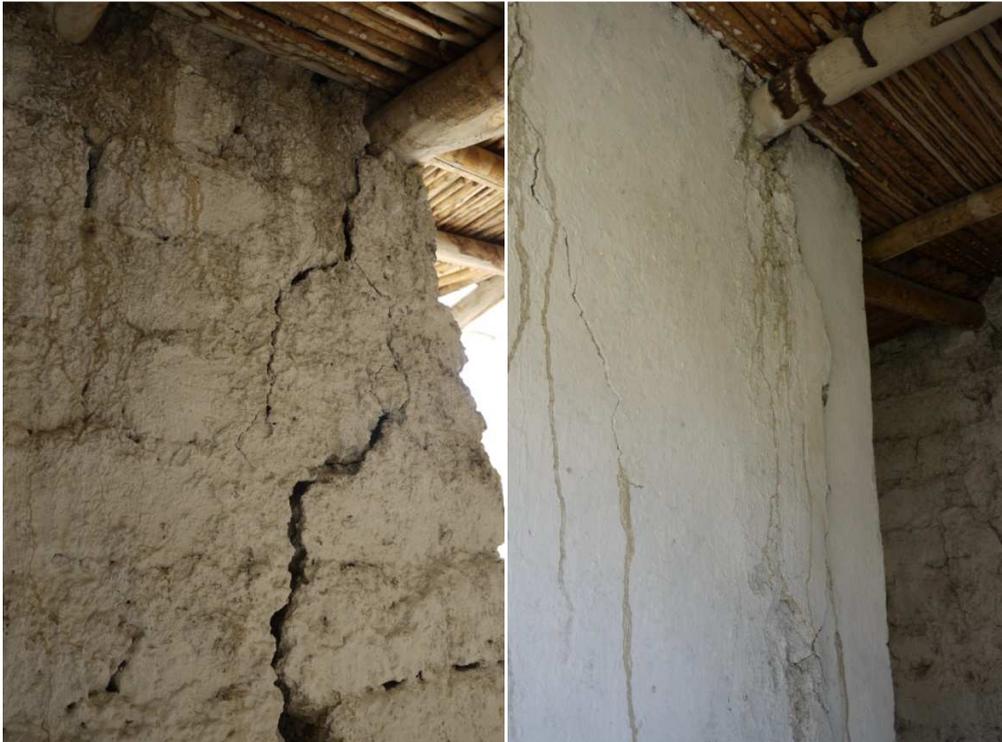
Fig. 95: Condition of the east wall of the inner structure: cracks (photo: Hilde Vets)

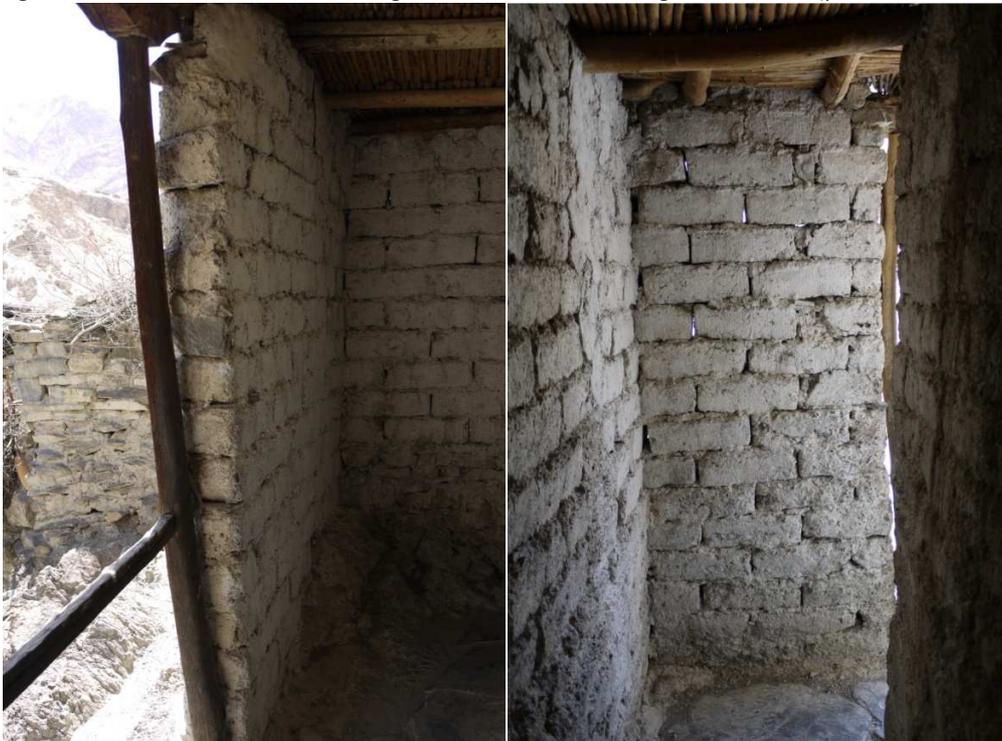
Fig. 97: Condition of the south wall and 'balustrade' of the outer structure. (photo: Hilde Vets)

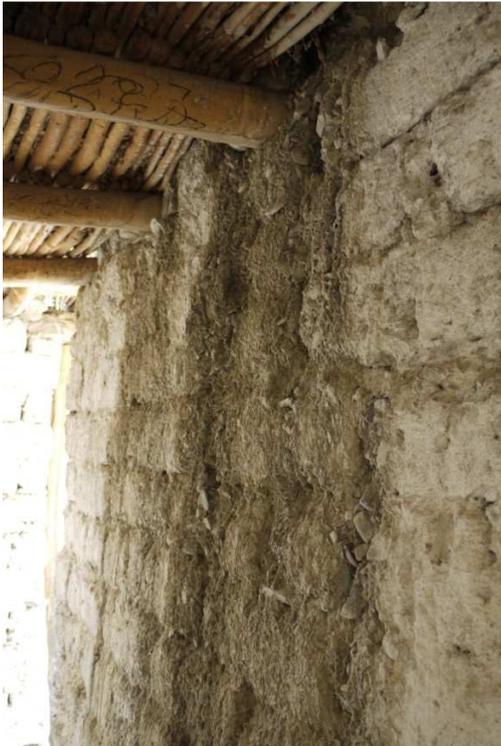
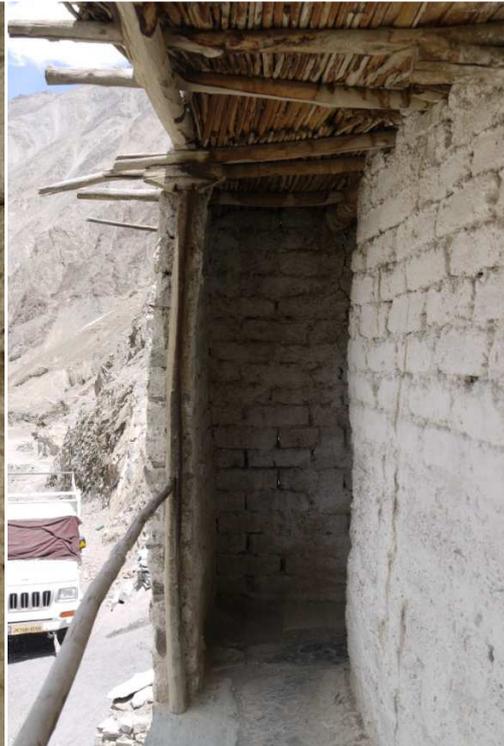
Fig. 99: Condition of the west wall of the inner structure. (photo: Hilde Vets)

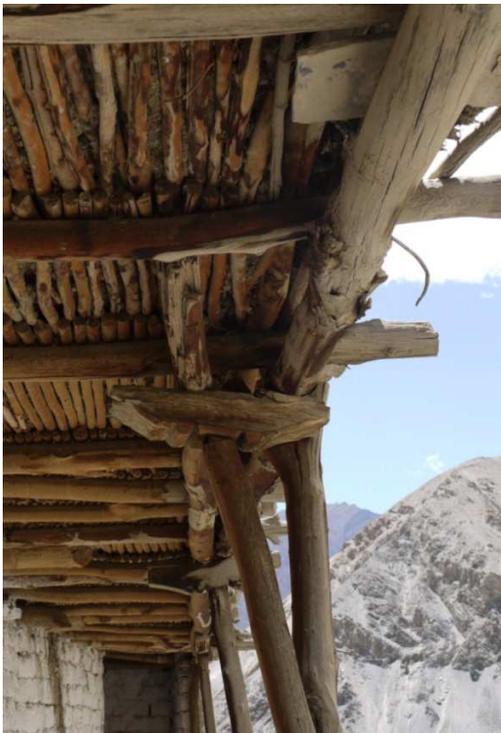
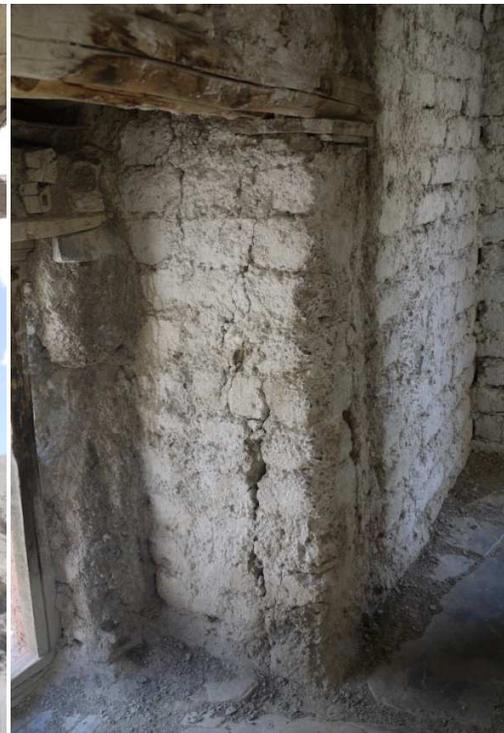
Fig. 101: Condition of the north 'balustrade': two carrying beams. (photo: Hilde Vets)

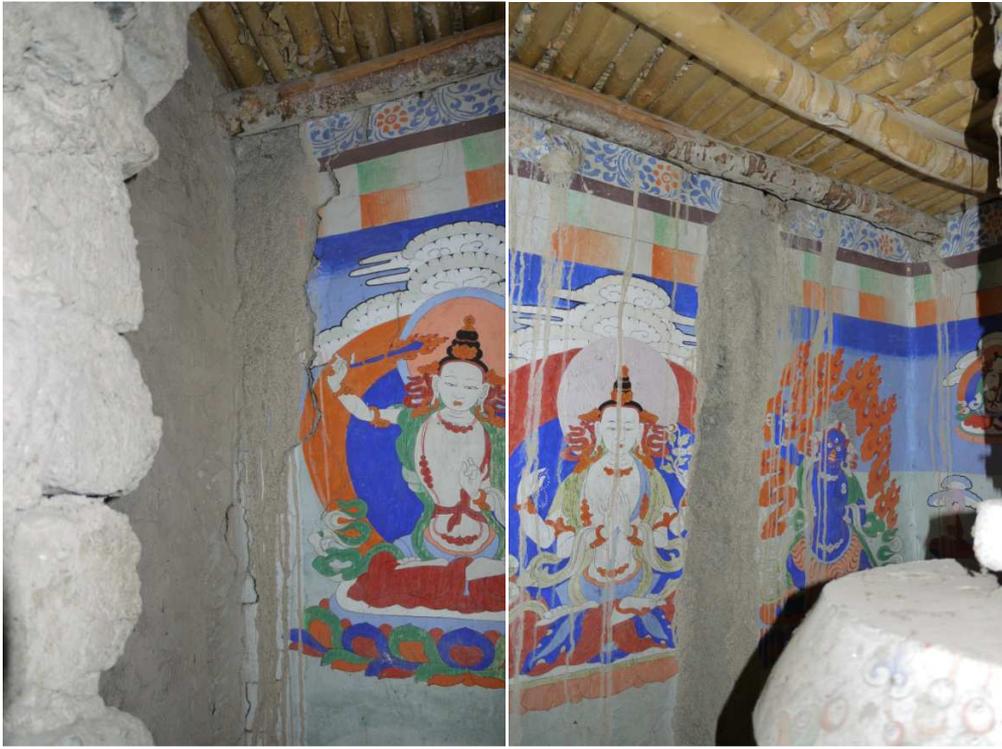
Fig. 103: Condition of the west painted wall: left side. (photo: Hilde Vets)

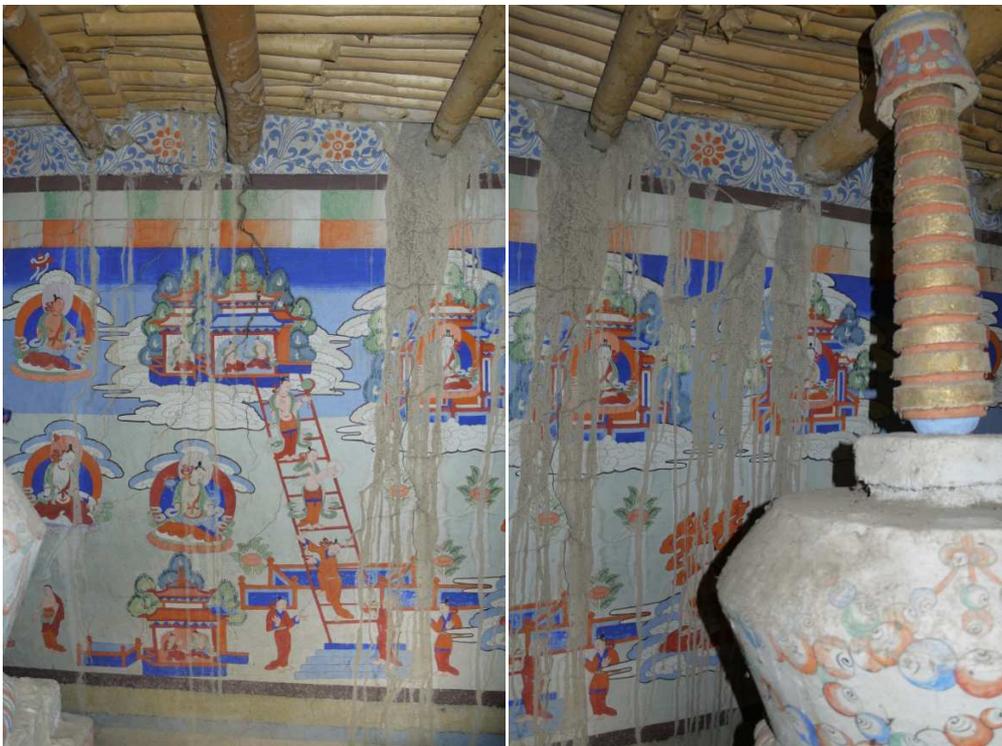
Fig. 105: Condition of the north painted wall: near W corner. (photo: Hilde Vets)

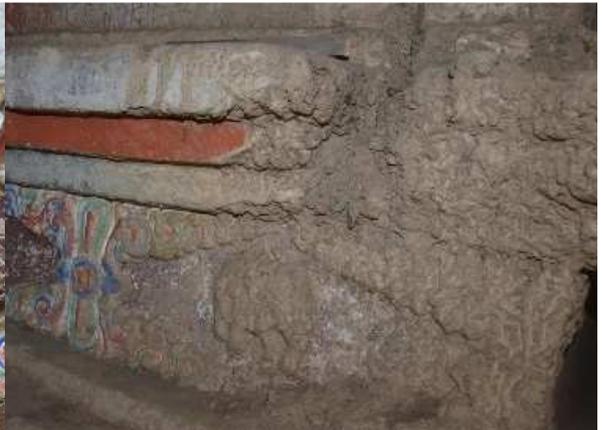
Fig. 16: Elephant, damaged by water together with the whole corner.

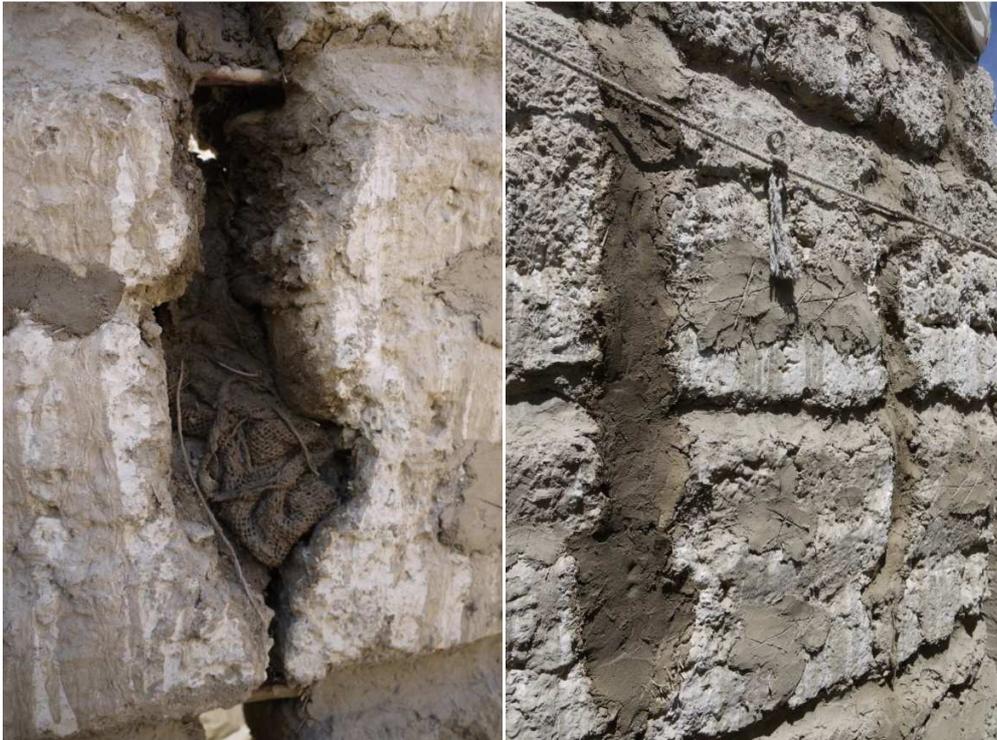
Fig. 113: East wall of inner structure: reinforced crack filled with jute bag soaked in mortar. (photo: Hilde Vets)
