**EARTHEN ARCHITECTURE AFTER DISASTER:  
INITIAL RISK-REDUCTION MEASURES  
IN KANJI VILLAGE FOR CONSERVING  
NON-ENGINEERED RURAL LADAKHI ARCHITECTURE**

This paper analyzes the damage to traditional earthen buildings in Kanji, linked to climate change, and appropriate solutions adopted in order to build new safe construction, and preserve the existing architectural heritage in a sustainable approach, respectful of traditional typologies and technologies.

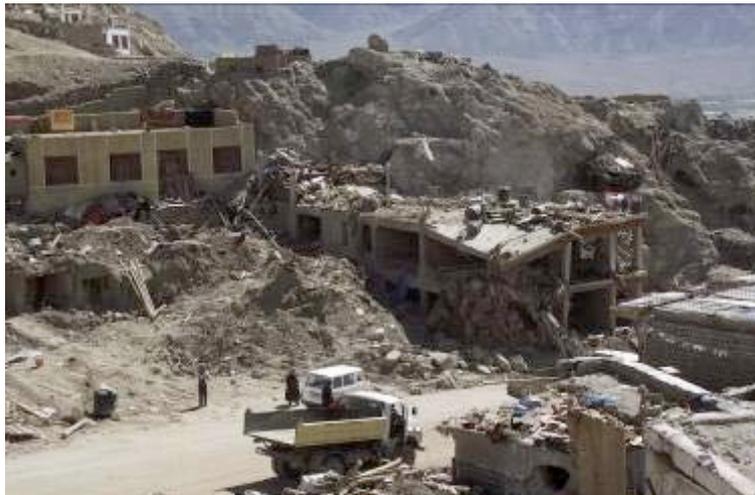
Fig. 1 – Leh, Ladakh: the destruction of the urban fabric after the heavy monsoon and related flood (credits: Désirée De Antoni, 2010)

At one time, extremely cold winters and temperate dry summers characterized the climate of this region. Over the last decade, instead, the amount of rainfall has experienced an exponential increase, and as a result, the damage to Kanji earthen architecture has been widespread. In 2010, the heavy monsoon made the situation worse, destroying a part of the city of Leh and many dwellings of villages all over Ladakh (Fig. 1).

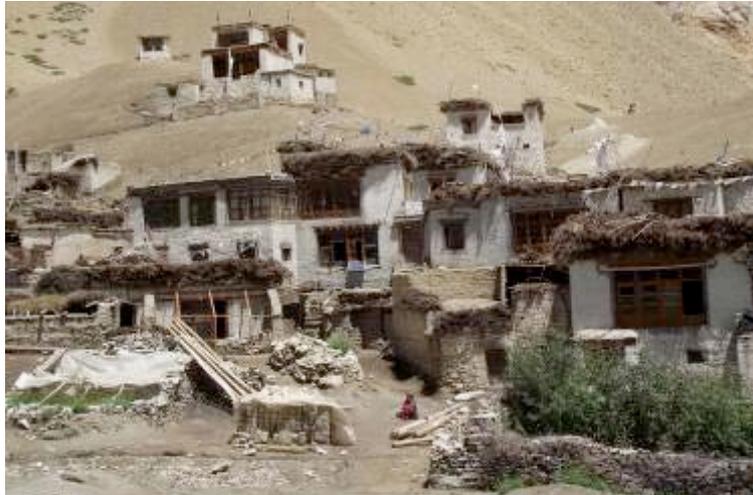
Kanji architectural typologies are basically three: buildings used as housing, buildings used for worship (temples and monastery), and public buildings (schools and meeting halls) (Fig. 2). These structures, within the framework of the *conservation manual*, have been evaluated for their state of conservation (good, sufficient, poor, or totally insufficient, which equates to a serious state of decay).

Fig. 2 – Kanji, Ladakh: the vernacular earthen architecture and the monastery (credits: Désirée De Antoni, 2010)

The architectural typologies of Kanji are characterized by the intensive use of earth, together with stone and wood, as basic building materials. The foundations of traditional buildings are built of stone; the load-bearing walls, as well as the internal framework, are executed with *pakbu*, the traditional earthen blocks. The floors and the roofs are constructed with poplar wood beams and willow sticks, vegetable fibers and a plaster mixture made of earth and water, called *markallak*.

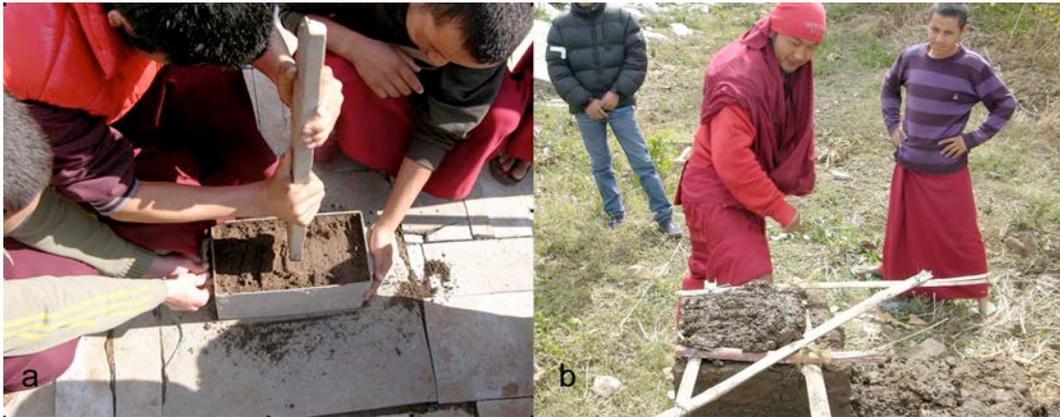
The “Earth Construction Practice” theme’s basic goal was to provide initial practical experience on earth construction through a brief field exercise of earth material-identification basic tests, production of traditional Ladakhi *pakbu*, and preparation of earth-based mortars and plasters according to the vernacular building culture, as well as improved mixture recipes. An awareness was also promoted on the importance of improving seismic strengthening of load-bearing walls, following the building technologies explained in the Indian Standards for earthen building. The Udine Unit, referring to the Indian Standards 13827/1993 - Improving Earthquake Resistance of Earthen Buildings, Guidelines, taught workshop participants, for instance, how to produce better quality *pakbu*, or how to create a correct *pakbu* masonry design, using appropriate improved mud-based mortars and plasters, and making sure of the correct distribution of the mortar in between two *pakbu* or in the laying of *pakbu* masonry (Fig. 6a). An improved corner joint for the walls, thanks to the introduction of a simple structure constituted by a band with two timbers in parallel and diagonal members for bracing at corners, was another important achievement of the “Earth Construction Practice” theme (Fig. 6b). This simple introduction to correct earthen-construction practices in seismic areas like Ladakh, supported by basic knowledge of architectural-conservation principles, will create a solid base for future improvements, included in the work-in-progress of the Udine Unit’s action in Kanji.

Fig. 6 – Dehradun, India, the winter workshop: (a) the production of different *pakbu* and; (b) the improved corner joint of the walls due to a simple structure constituted by a band with two timbers in parallel and diagonal members for bracing at corners (credits: Mauro Bertagnin, 2011)
