Restoration of the 8 chörten building

Wanla, Ladakh, India

Achi Association India

11 October 2014

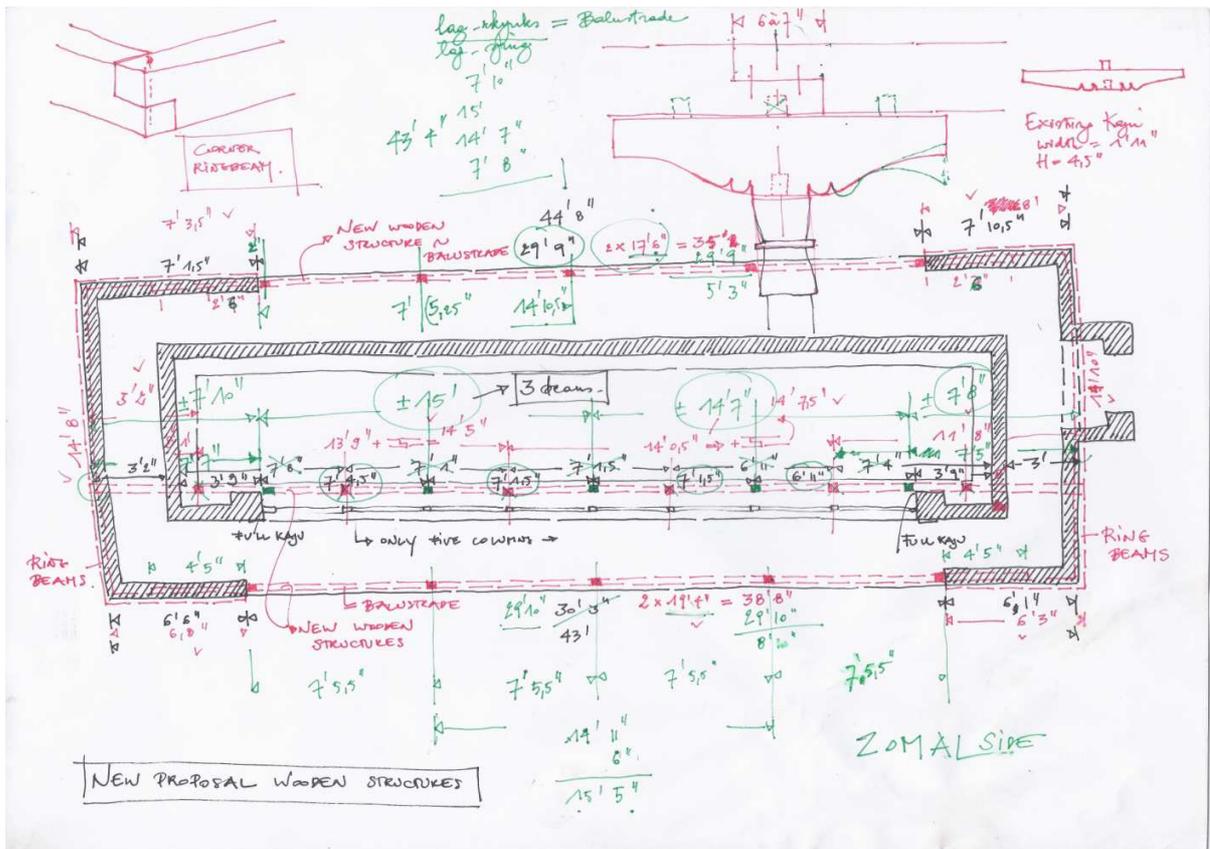
Fig. 16: New restoration proposal (sketch on site: Hilde Vets)

As the supporting columns and beams of the existing 'balustrades' weren't sufficient to carry the load of the roof, they would be replaced by new wooden structures (columns, capitals and rectangular beams). An extra wooden structure behind the wooden screen would help to take away the load from this screen and from the inclining wall. Roof joists running from one side to the other would spread the load as well over these three new supporting structures.

Ring beams placed on top of the walls and tied together with these new structures, would make a rigid construction of the entire building.

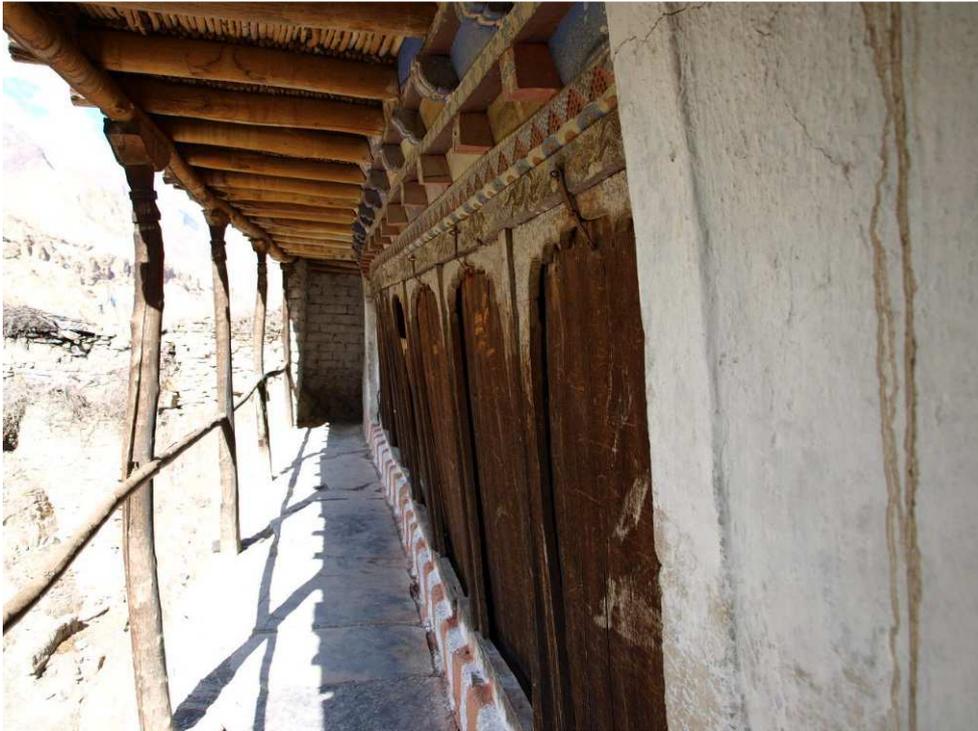
Fig. 22: The window screen from the entrance area, before construction work started. All shutters are closed. (photo: Anne Voll)

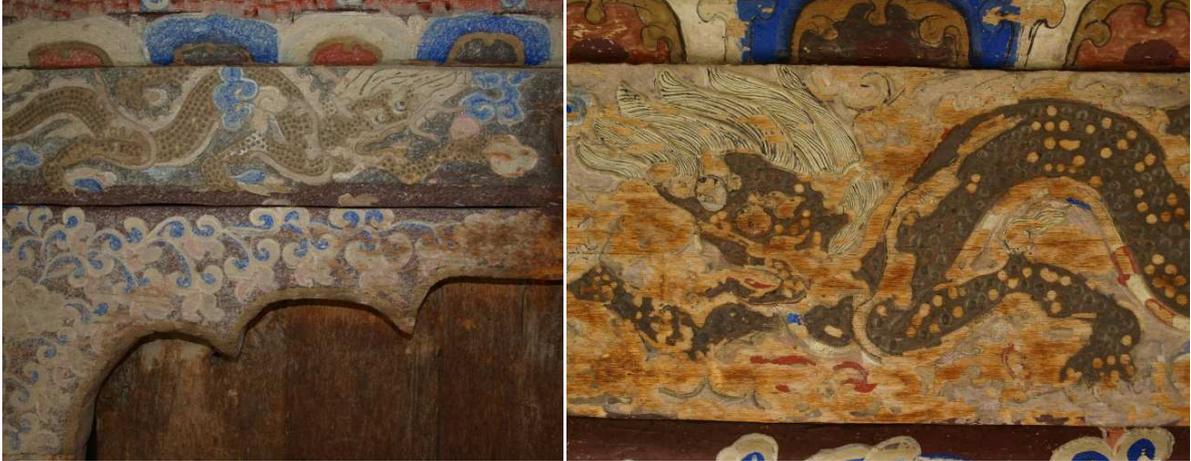
Fig. 23: Detail of the screen: dragon and clouds done in 'pastiglia' technique. (photo: Björn Bühler)

Fig. 24 : Losses in 'pastiglia', causing a 'negative' effect in the design. (photo: Anne Voll)

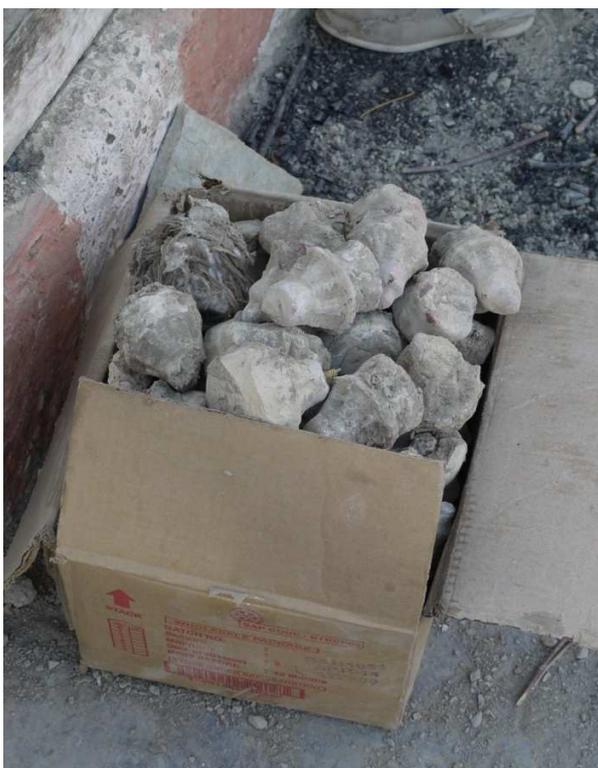
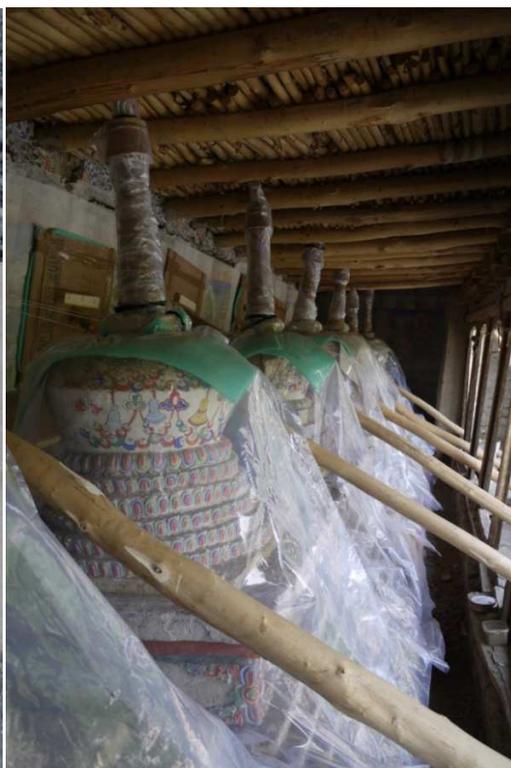
Fig. 28 : *Tsha-tsha* collected from the chörten. (photo: Hilde Vets)

Fig. 29 : The chörten protected with foam and plastic. (photo: Hilde Vets)

Afterwards, the chörten were wrapped. As the roof would be removed, they had to be protected against possible rainfall as soon as they would be exposed to the elements. Also, there was a risk of objects (stones, *talu*, earth,...) falling down during work in progress. They were covered with soft foam before wrapping them with strong plastic sheets.

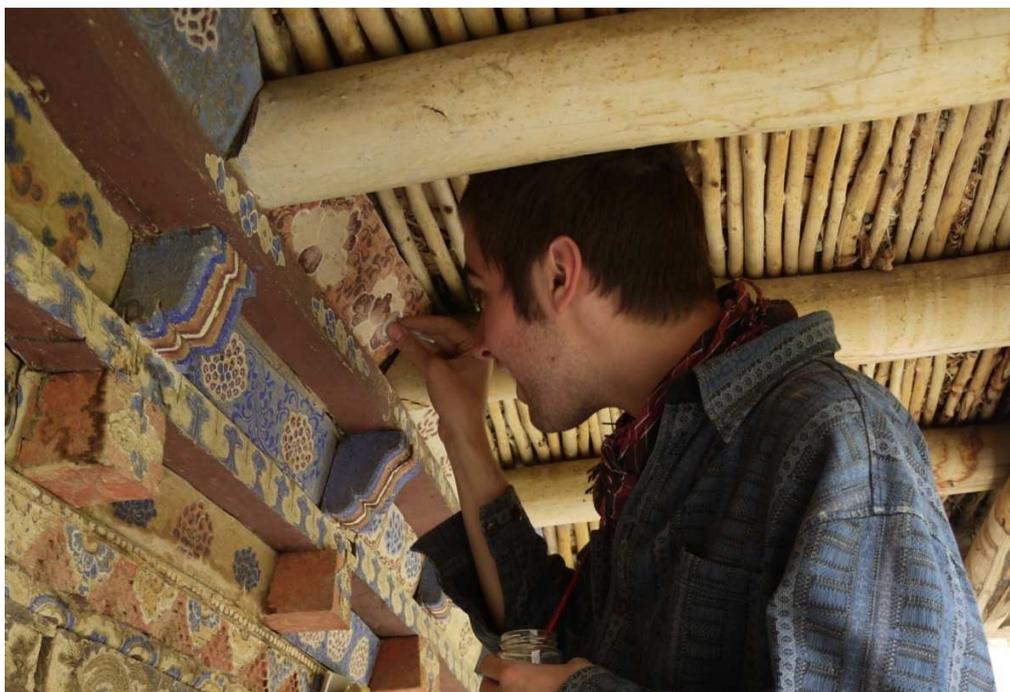
Fig. 30 : Björn Bühler securing the paint layer. (photo: Hilde Vets)

To prepare the window for the coming work and as an emergency measure, the screens' paint layer was consolidated. Loose paint layer was treated with injections of fish glue (appr. 5% in water). Where the paint layer had cracked up, the fish glue was applied through Japanese paper with a soft brush. To help reattaching the paint layer to the wood, it was pressed gently with non-sticking plastic foil.

As the screen also had to be propped, the paint layer was secured with a double layer of Japanese paper against the mechanical stress. The paper was glued reversibly with Klucel E in water. Additionally, a soft padding was applied between props and underground. As soon as the roof was exposed, the screen was covered with plastic sheets.

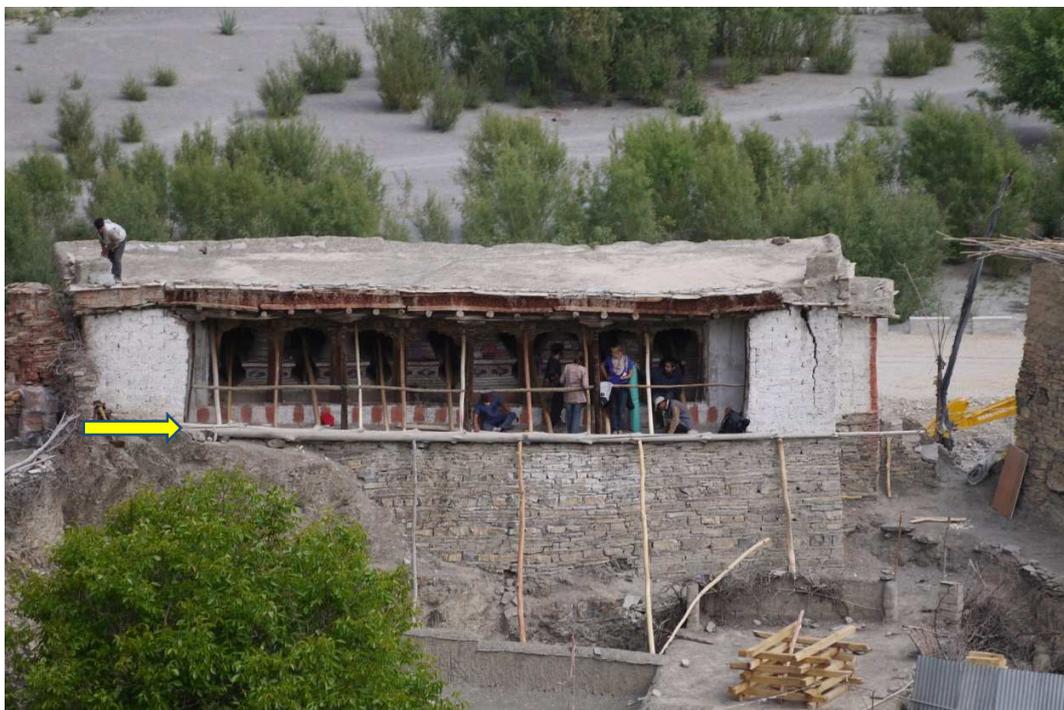
Fig. 33: Propping of the building. The arrow is pointing at the long supporting trunk (photo: Hilde Vets)

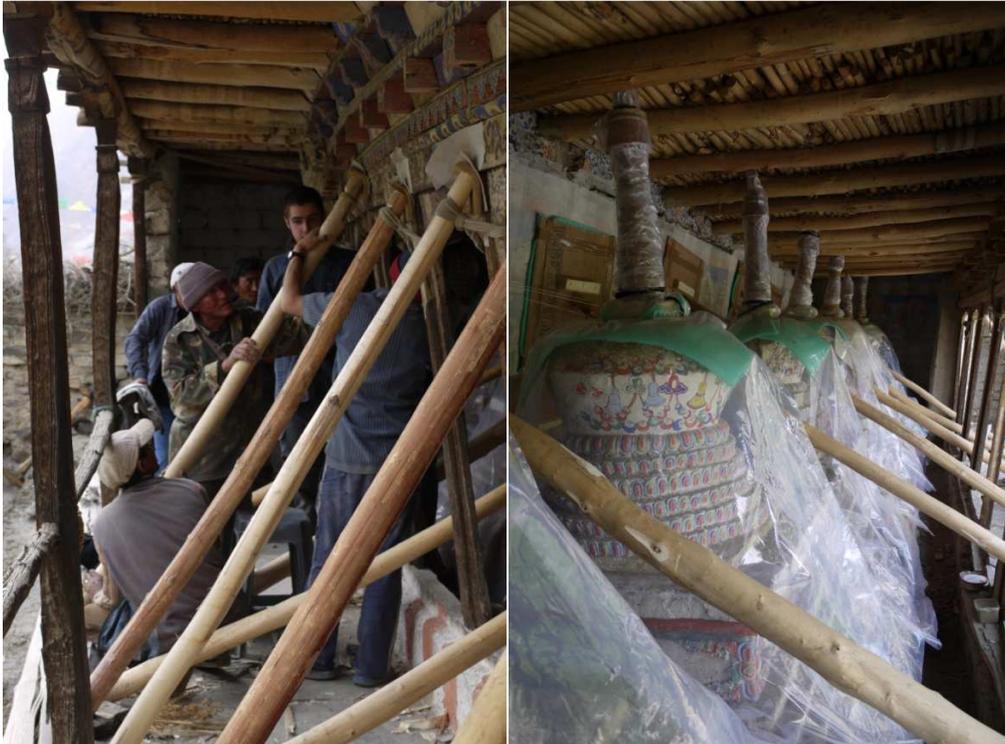
Fig. 34-35: Propping of the screen and of the inclining wall, with protected chörten (photos: Hilde Vets)

A secure propping of the building was needed to be able to take down the roof and to avoid the collapse of the inclining wall and window once the load of the roof would be removed.

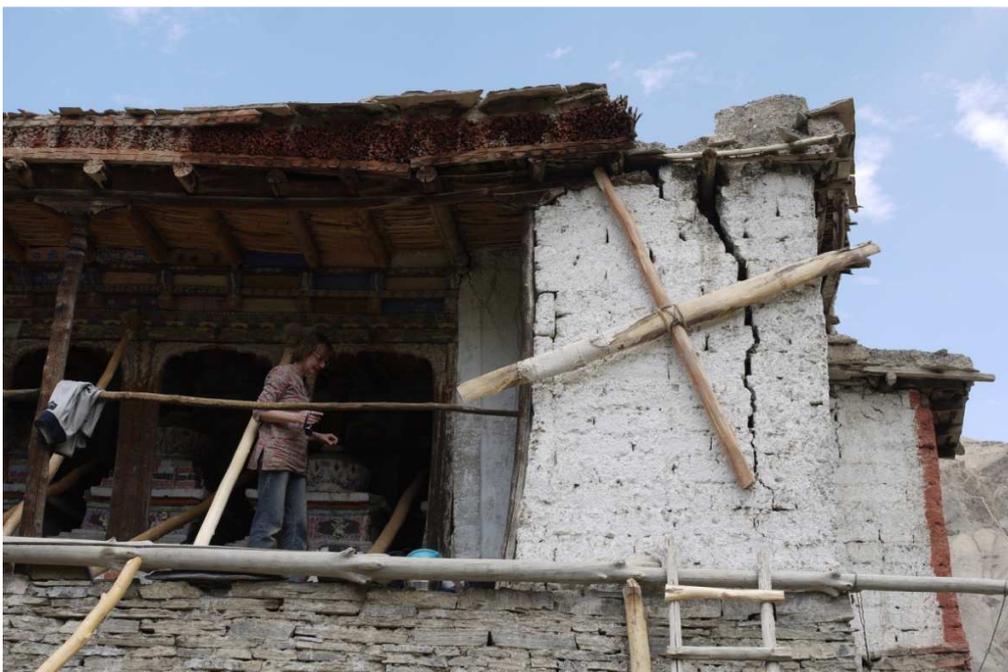
Fig. 36: Extra tying of the right wall and balustrade at the south façade (photo: Hilde Vets)

We also decided to secure the very damaged right wall and “balustrade” (column/beam) of the south façade to avoid it from shifting away during the demolition of the roof.

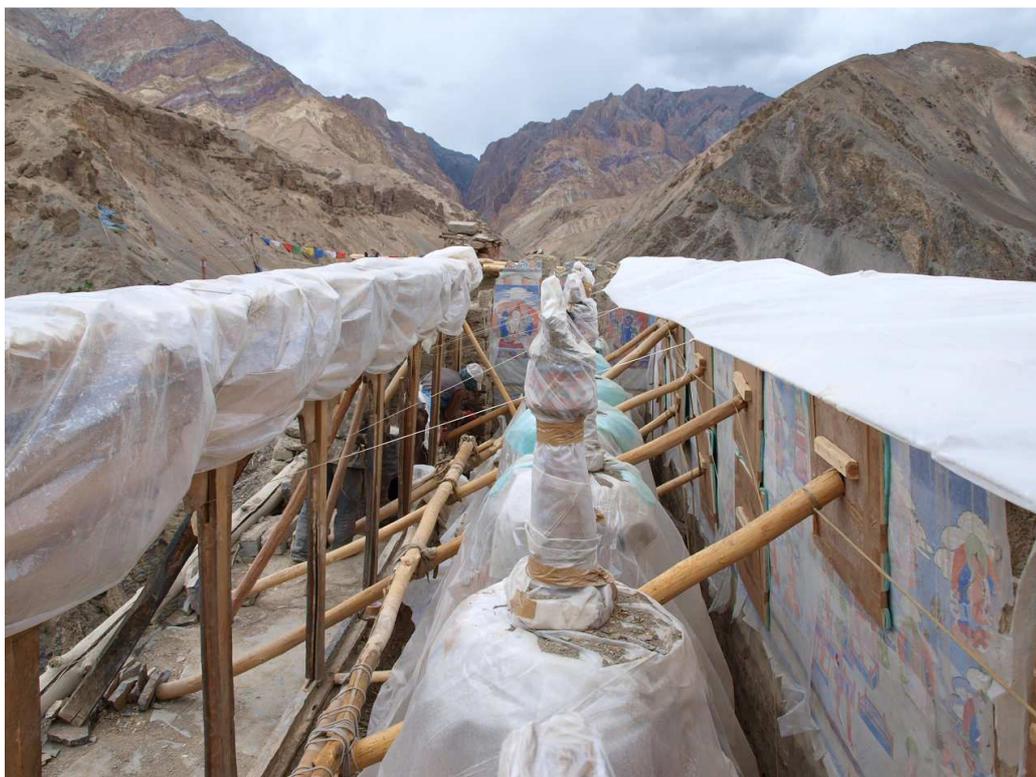
Fig. 40: View into the inner structure after the roof was removed. Screen, chörten and wall paintings were covered with plastic sheets. The wall paintings were secured with Japanese paper, the props kept the screen and wall stable. (photo: Anne Voll)

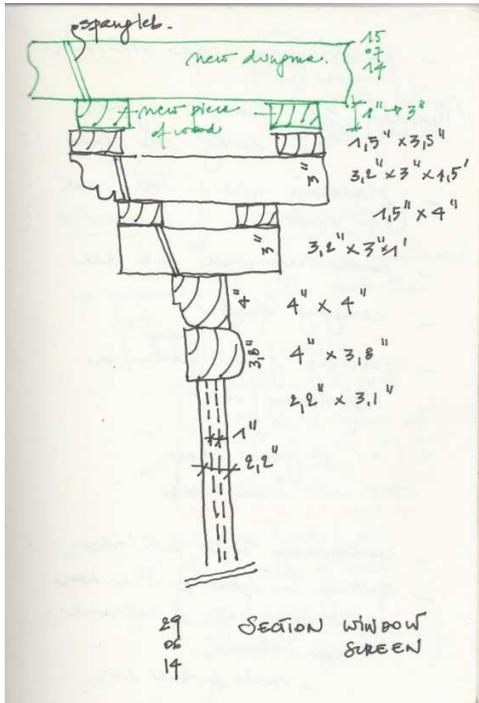
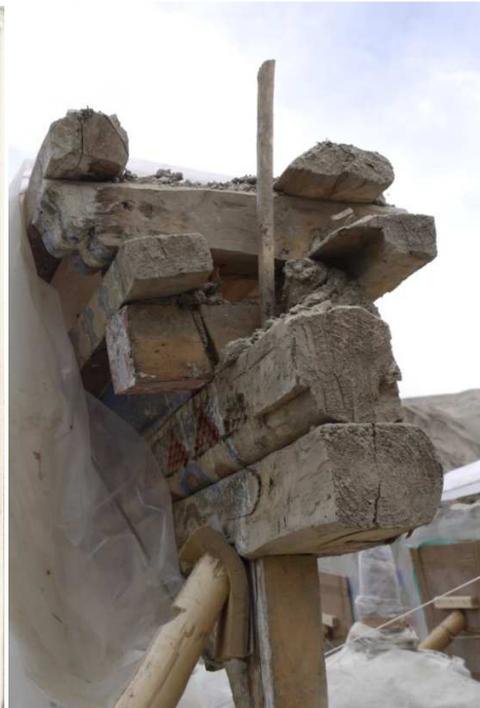
The entire wooden screen was leaning very much outwards (idem inclining wall), also at its ends. This affected the short walls right and left of the screen. Certainly the right wall – being washed out at the inside and separating from the adjoining wall – was leaning badly and a lot of cracks had appeared.

Fig. 45: Section of the wooden screen – with proposal for new *dungma* (sketch: Hilde Vets)
Fig. 46: Wooden screen after removal of the right adjoining wall (photo: Hilde Vets)

We decided to take down a part of this wall and buttress to 6 rows above the ground level – the height where the crack in the wall, separating the corner, stopped. This way we could straighten the screen and mason it back into the newly built wall.

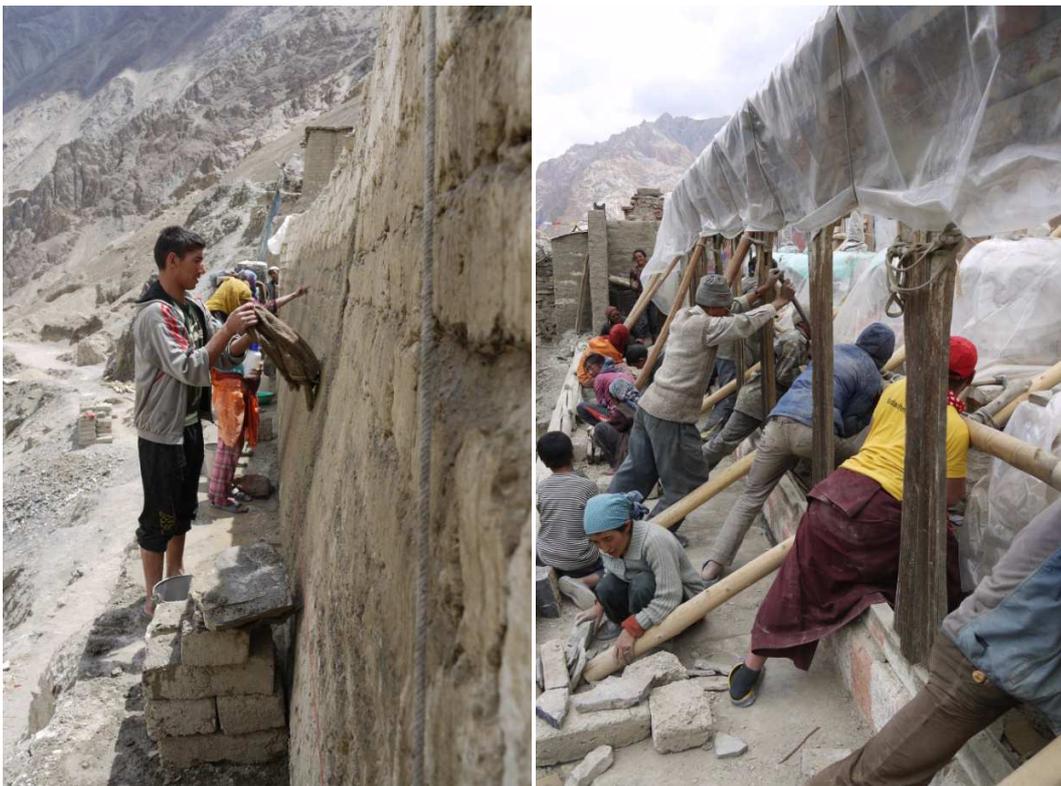
Each trial we managed to move the wall with some centimetres, at the end resulting in 31,5 cm (1'0,5") at the middle of the wall. We decided to stop pushing when the cracks near the northeast corner started to open more. The wall was left inclining about 9 cm at most (in the middle), meaning only half the width of the mud brick.

Fig. 52: Pushing of the painted wall. (photo: Hilde Vets)

In total 10 men were pressing the wall, using iron poles as lever, and 7 women were sticking stones behind the props. Meanwhile conservator Anne Voll and architect Hilde Vets were supervising the paintings that no cracks appeared or worsened during the process.

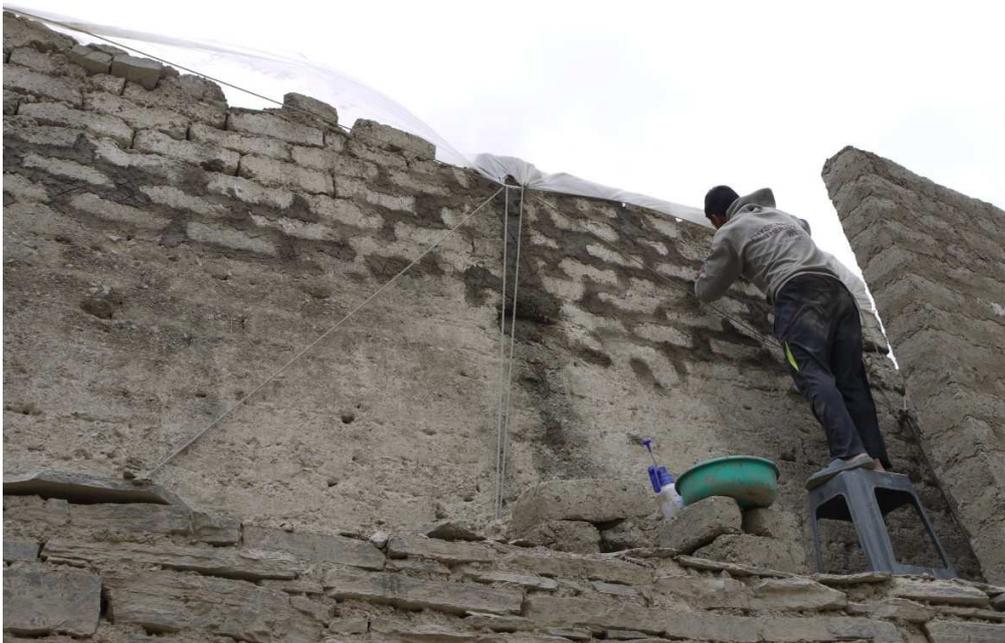
Fig. 54: Filling the open joints of the backside of the painted wall. (photos: Hilde Vets)

Once the painted wall was straightened to an almost upright position, the joints on the backsides of all the walls of the inner structure were filled again with a mud mortar.

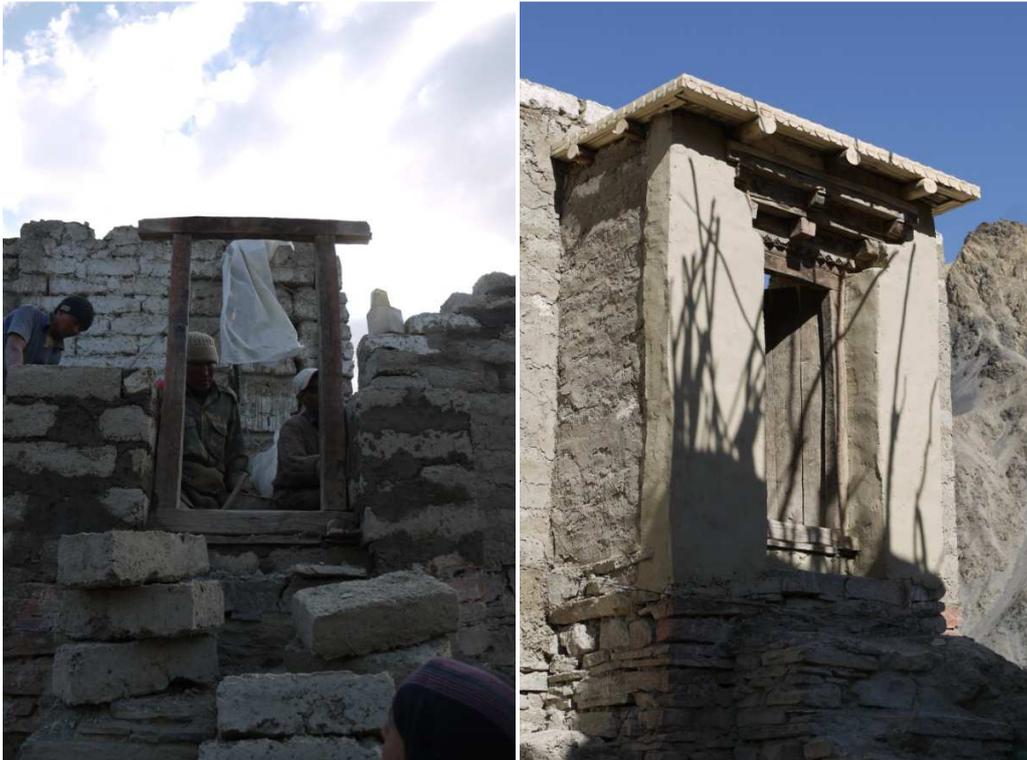
Fig. 66-67: Re-placement of the original door and new '*mutik shing*'. (photo: Hilde Vets)

As the original woodwork (horizontal bar with cut-out circles - *mutik shing*¹⁷) at the overhang of the roof was in a very bad condition and parts of it were lacking, we had new parts cut according to the original design (which is different from present).

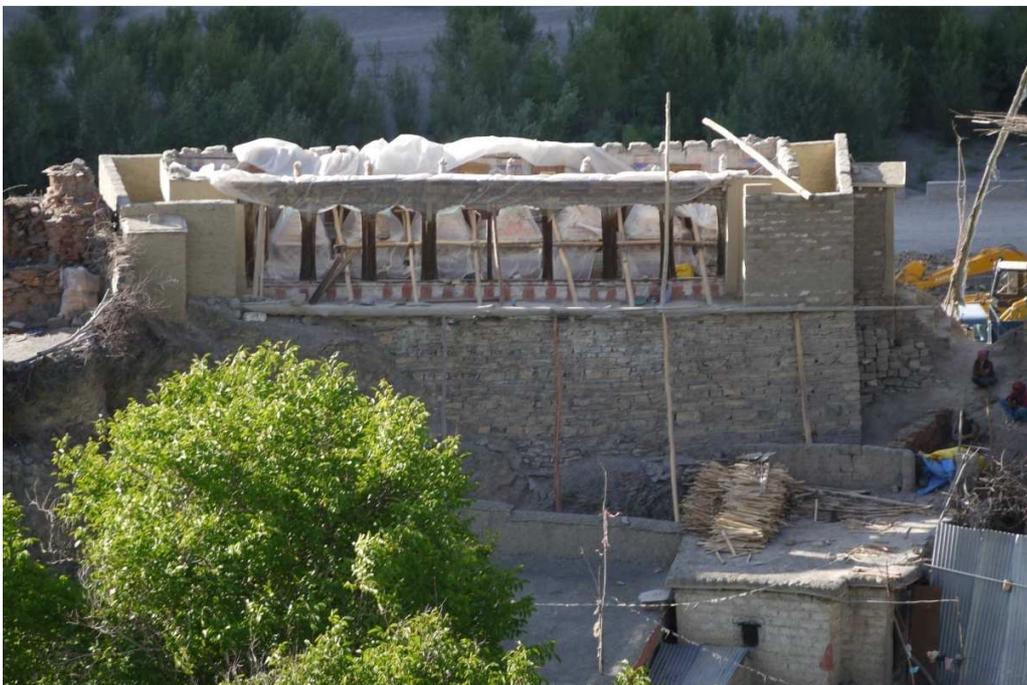
Fig. 68: All the new outer walls reconstructed and painted with *markalag* where reachable. (photo: Hilde Vets)

Around the door opening a plaster layer was applied, similar to the former one (see fig. 68).

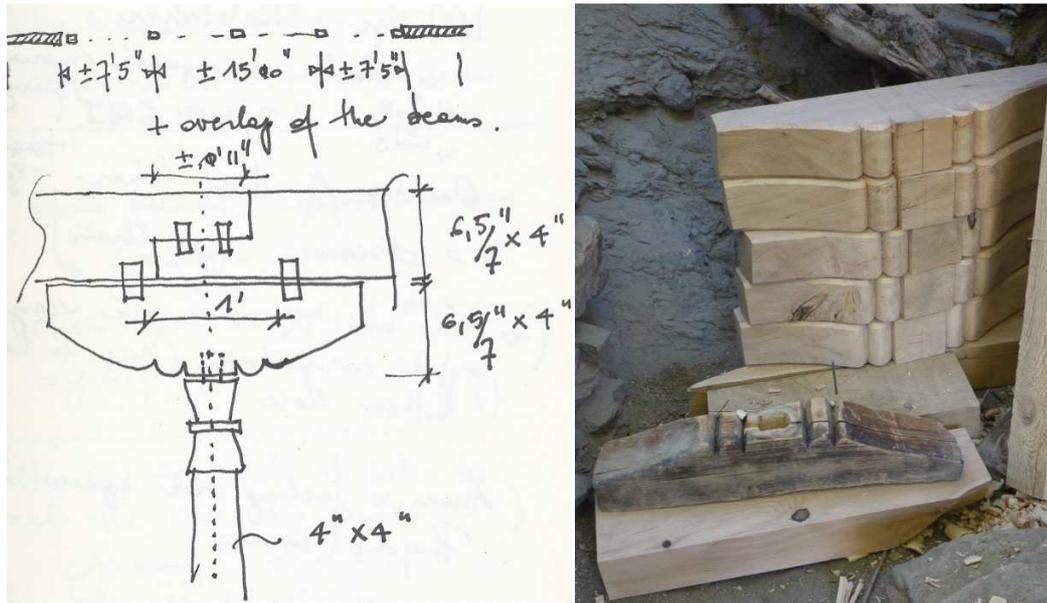
Fig. 69: Sketch of the new structures. (photo: Hilde Vets)

Fig. 70: Capitals made similar to the original capital. (photo: Hilde Vets)

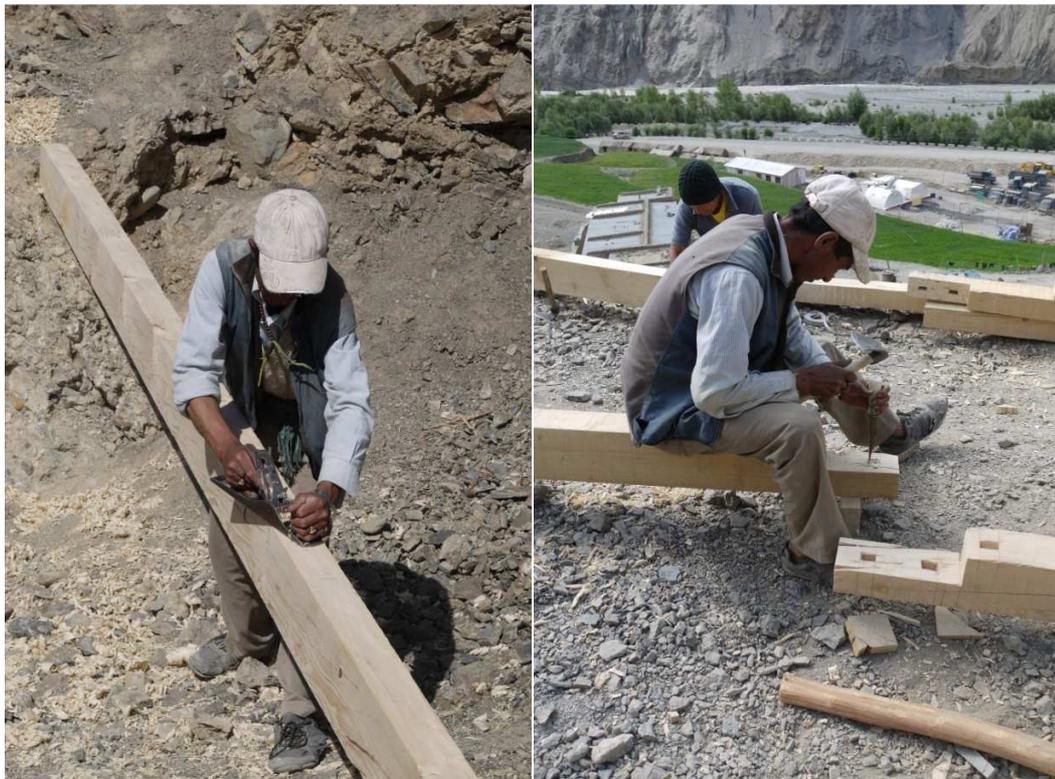
Fig. 71: Puntsok Dorjay planing the beams. (photo: Hilde Vets)

Fig. 72: Puntsok Dorjay and Tsewang Gyaltsen making mortises in the beams. (photo: Hilde Vets)

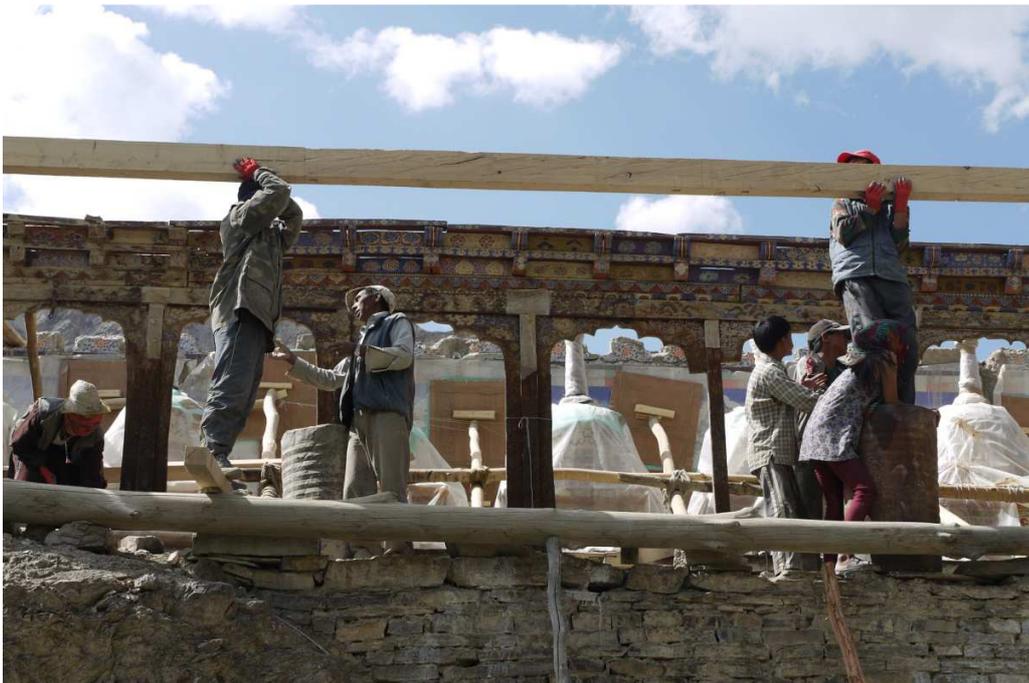
Fig. 73: Holding the supporting beam before putting in the columns . (photo: Hilde Vets)

Once all wood work was prepared, we started putting up the first structure at the south facade. The heights of the supporting walls were levelled; the bases (floor of the circumambulation veranda) of the columns were repaired where necessary; the columns were laid out at their respective place; the capitals were fixed on the columns and the beams were raised with ropes from the neighbouring roof to the inside of the building.

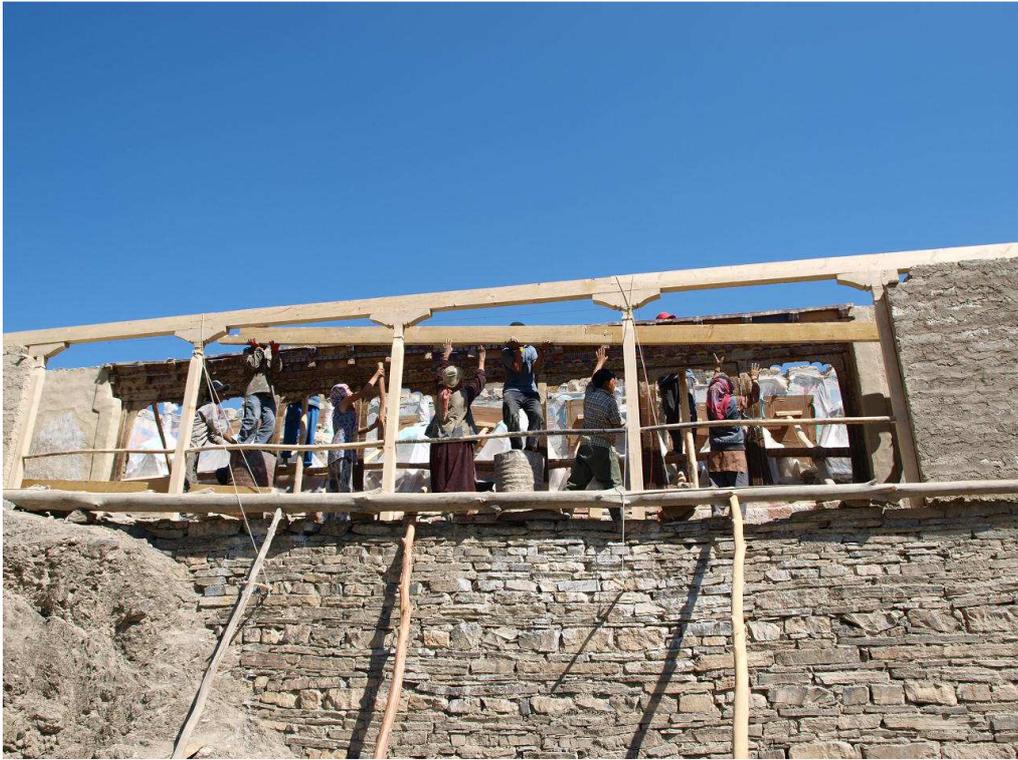
Fig. 74: Raising one beam of the second structure inside the shrine . (photo: Hilde Vets)

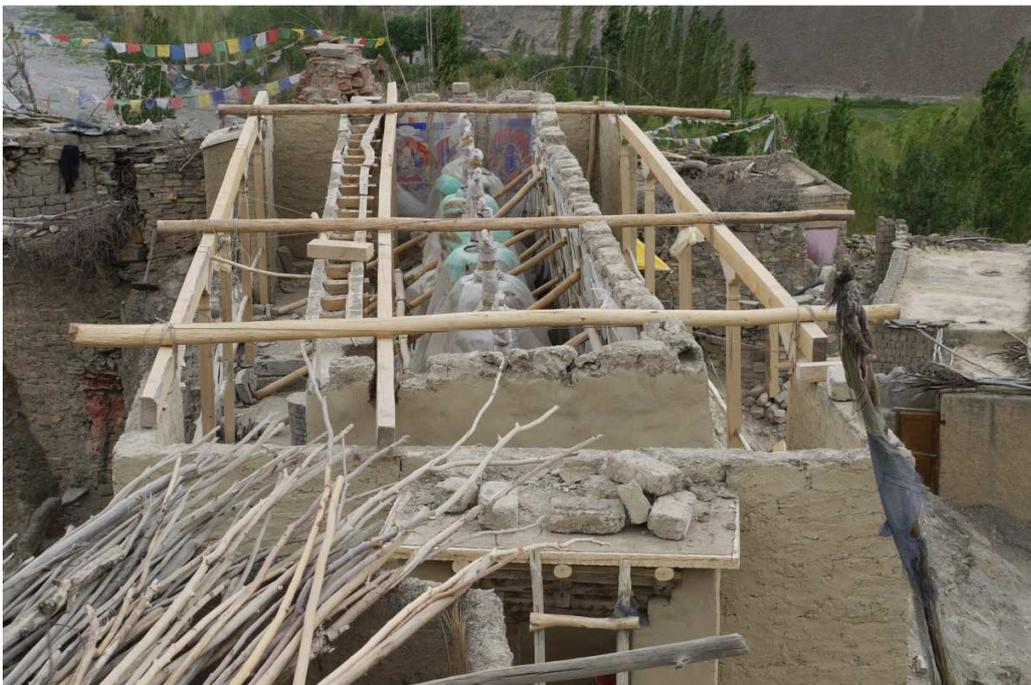
Fig. 75: The three structures put in place . (photo: Hilde Vets)

Then ring beams were put on top of the surrounding walls and the three structures were fixed with them, either with screws and nuts and bolts, either with tenons.

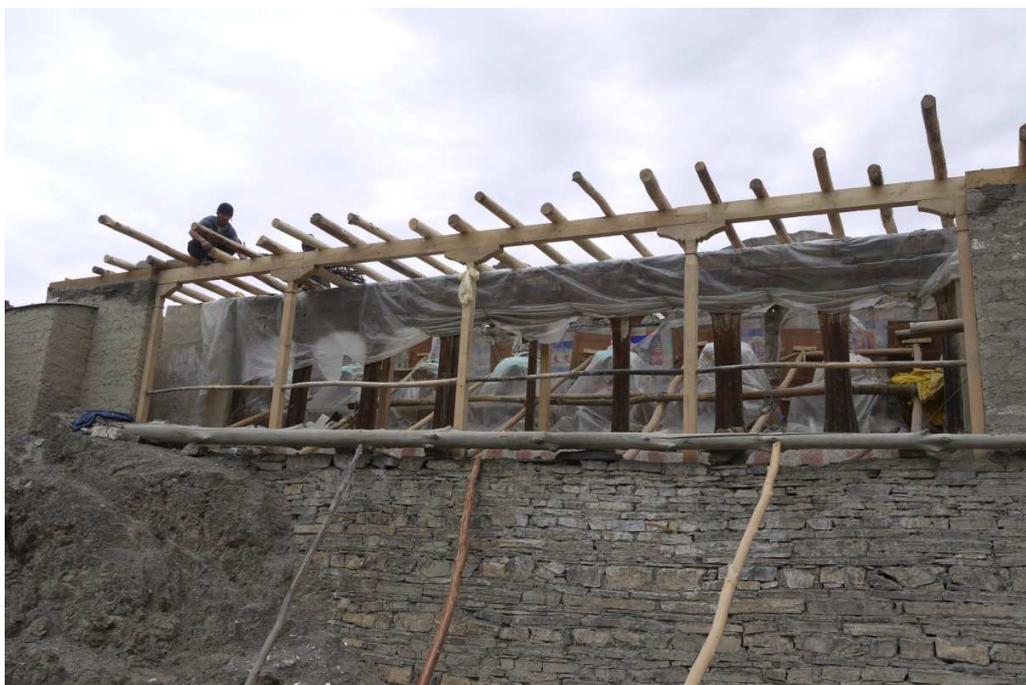
Fig. 76: Placing the joists on the roof. (photo: Hilde Vets)

The original wooden boards (*spang-leb*) were replaced in the traditional way by cutting out grooves in the joists. On the north side we decided to copy the situation at the south ‘balustrade’ where there used to be (not painted) boards as well.

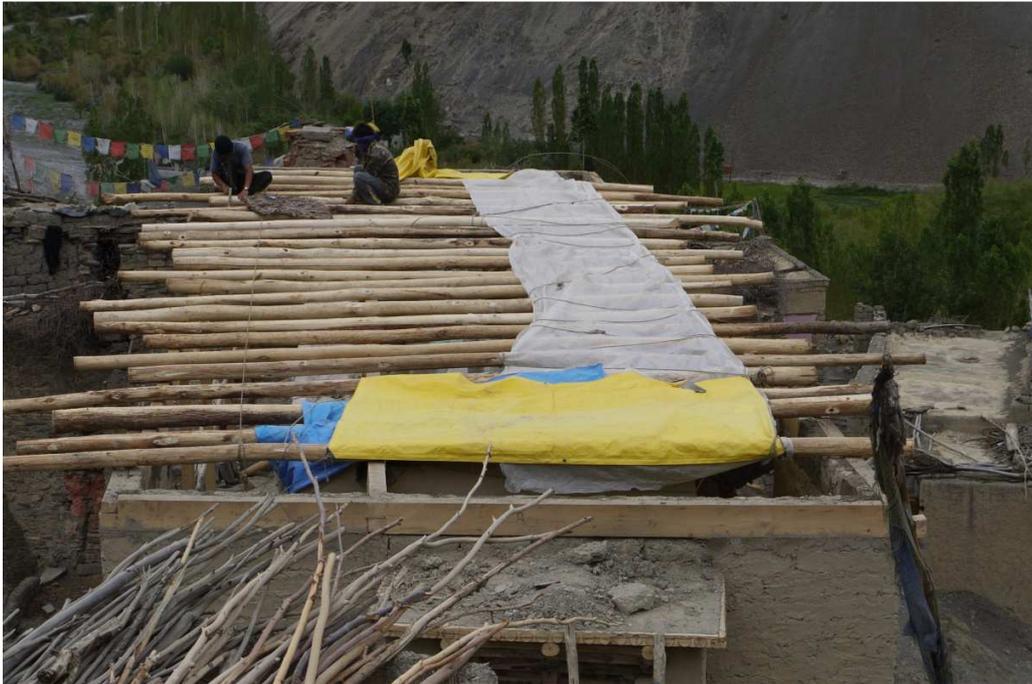
Fig. 77: Cutting the joists to the correct length. (photo: Hilde Vets)

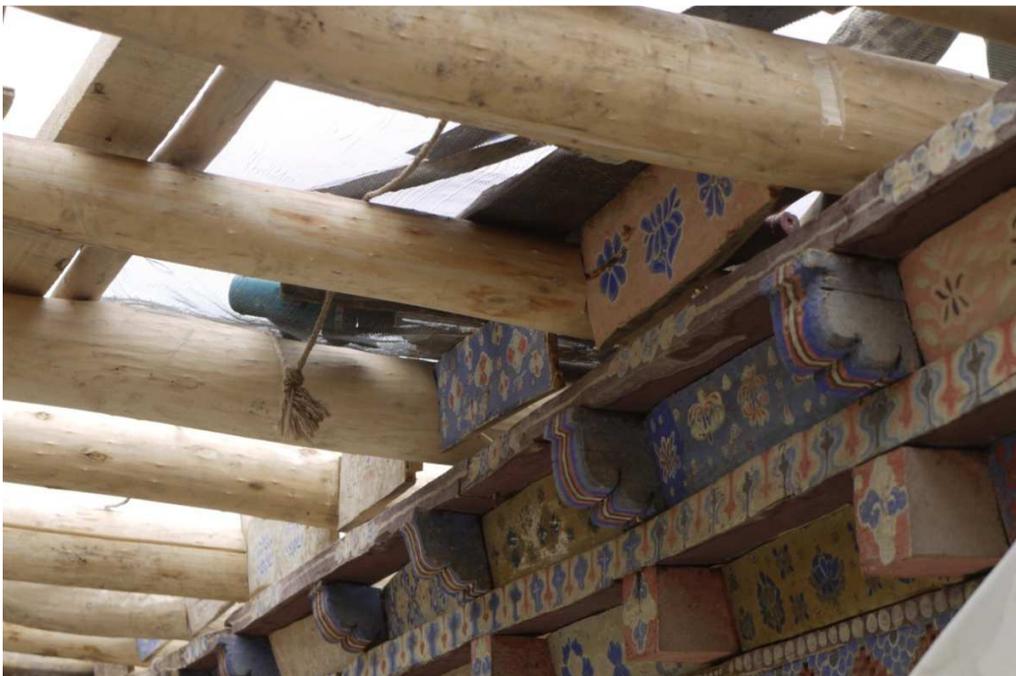
Fig. 78: Positioning the painted boards (*spang-leb*) above the screen. (photo: Hilde Vets)

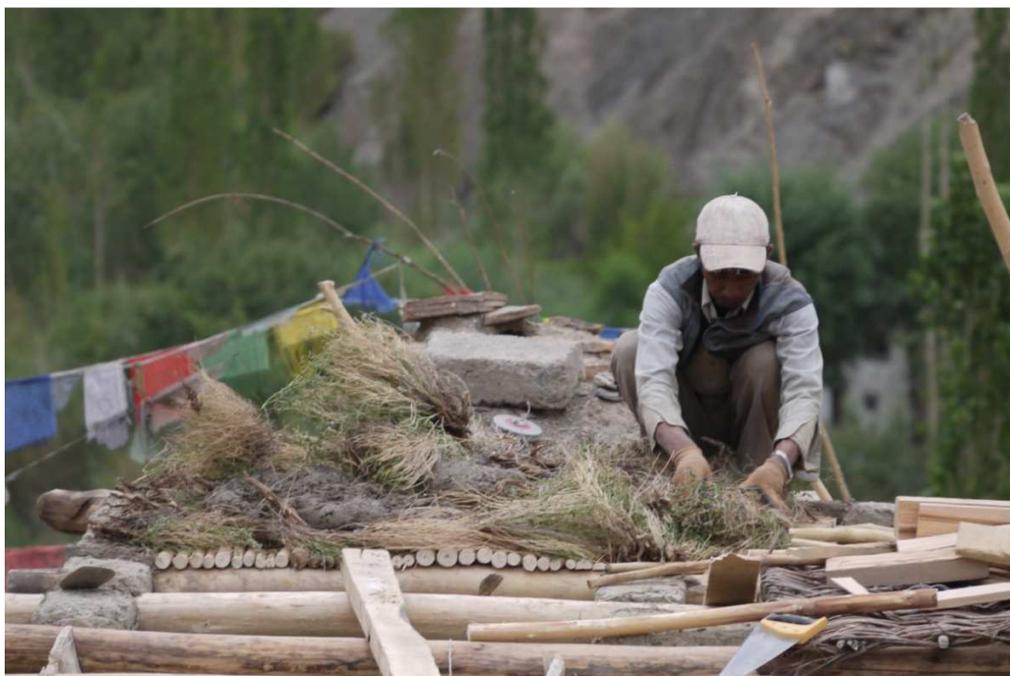
Fig. 79: Arranging the *talu*, putting the mountain grass and fixing it with mud. (photo: Hilde Vets)

Then the willow branches were arranged on the roof, as support for the traditional layered roof: a layer of mountain grass, two layers of mud mortar (mixture of earth from the fields, recuperated earth, river sand and straw) and one layer of fine clay (*markalag*).

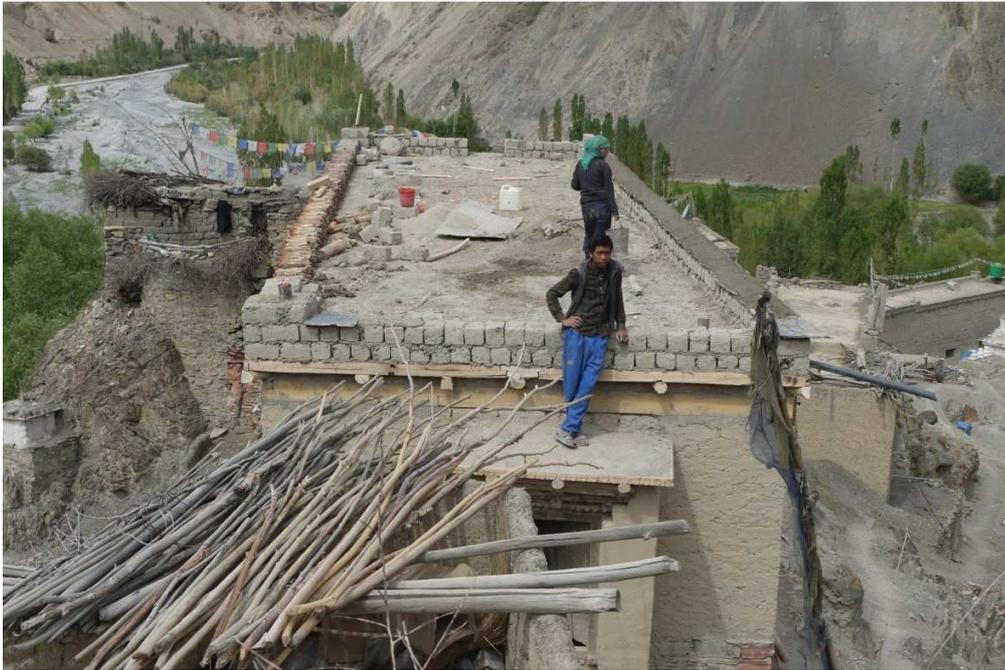
Fig. 80: Construction of the parapets with willow twigs and small *phagbu*. (photo: Hilde Vets)

The wooden bars underneath and on top of the parapets were re-made out of the rest of the beams and out of recuperated trunks (the carpenter in the village cut them to the right size with a saw machine). The parts positioned at the *spedma* (parapet made with *talu*), were decorated with small circles or *mutik*, like it was before.

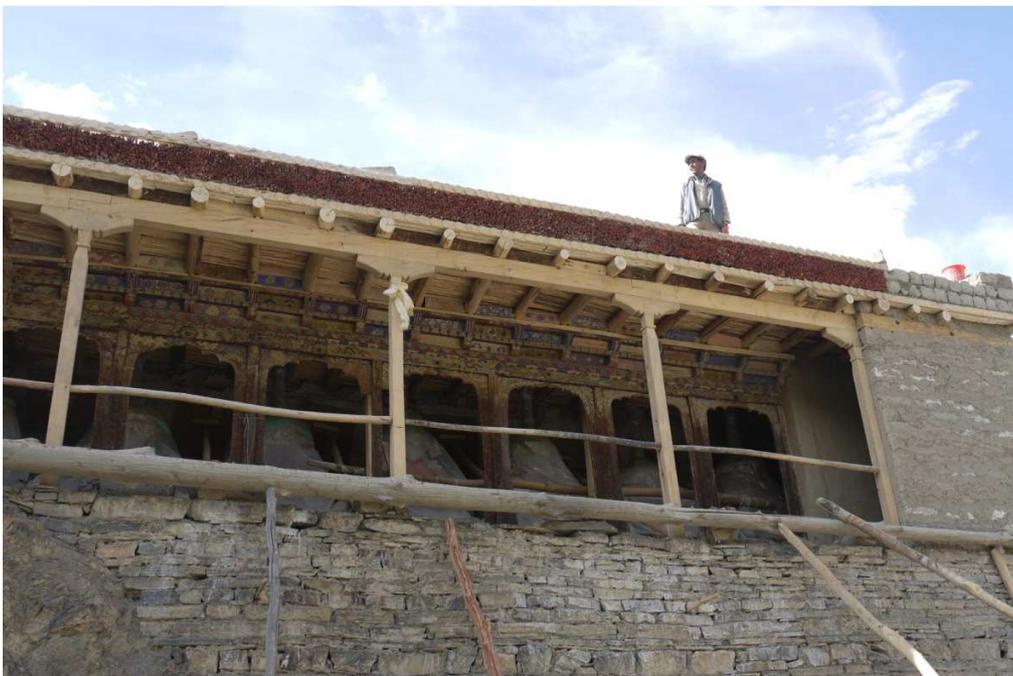
Fig. 81: View at south facade with the (almost finished) parapet, at the moment that architect Hilde Vets and conservator Anne Voll left. (photo: Hilde Vets)

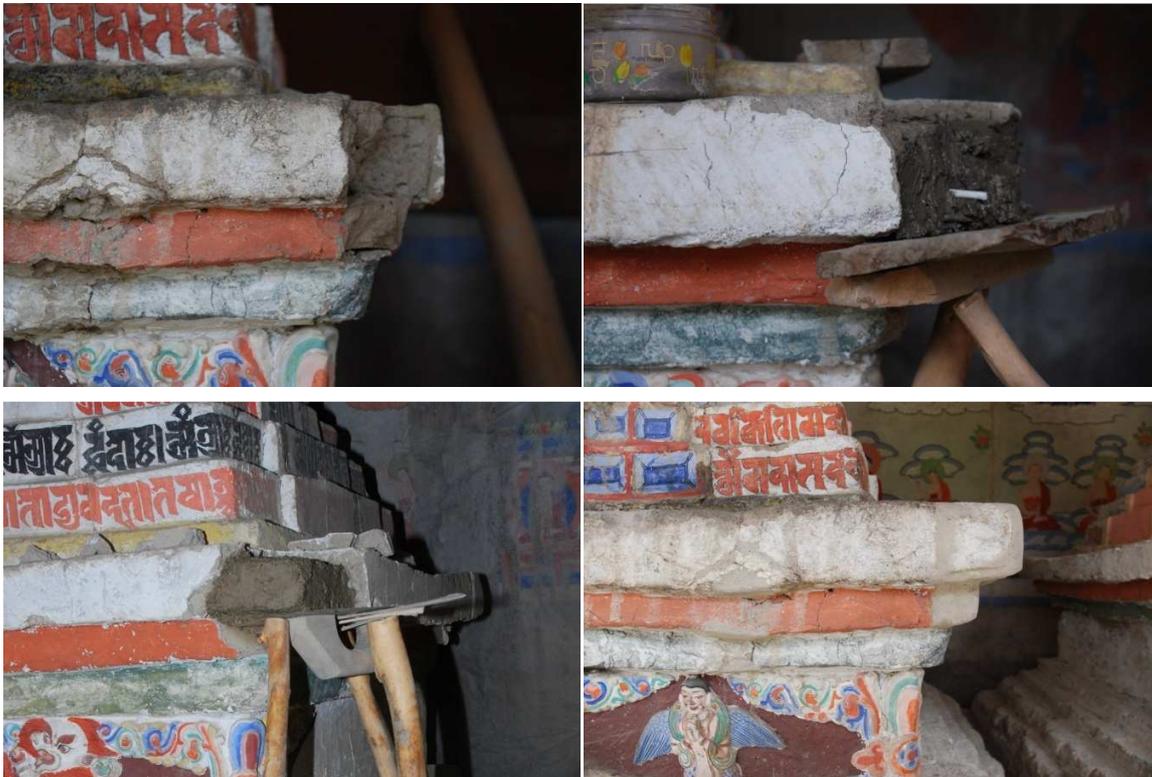
As some of the chörten suffered broken edges, these had to be fixed or reconstructed. For the fixing of the recuperated corners, dowels of carbon fibre were inserted and glued with a mortar of *markalak* and a bit of the cellulose glue Tylose (5% in H₂O).

Fig. 84: Reconstruction of the corner of a chörten (photos: Susanne Bosch)

The cracks around the newly applied corners were filled with a fine *markalag* mortar (*markalag*, sieved riversand and 5% Tylose in H₂O).

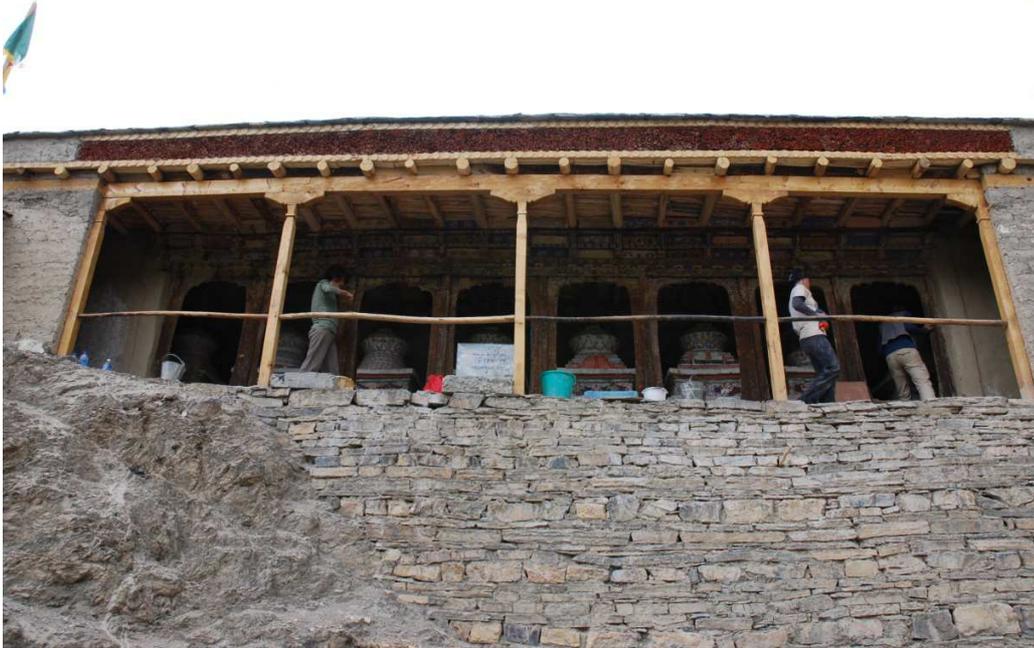
Fig. 85: Treatment of the new wooden structures by the second team: south facade. (photo: Susanne Bosch)

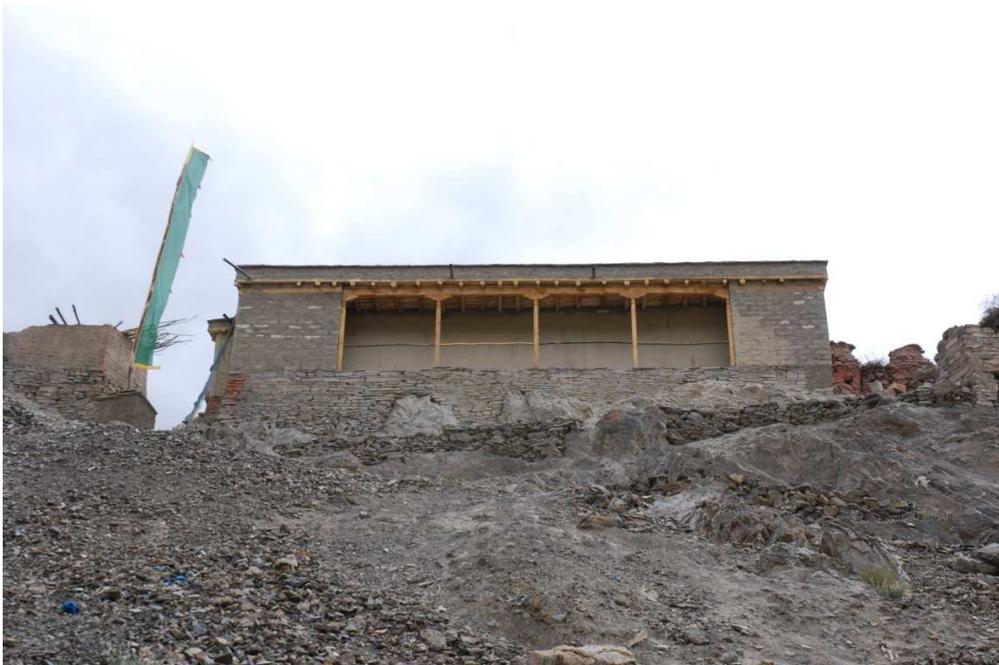
Fig. 86: Treatment of the new wooden structures by the second team: north facade. (photo: Susanne Bosch)
