Restoration of the 8 chörten building

Wanla, Ladakh, India

Achi Association India

11 October 2014

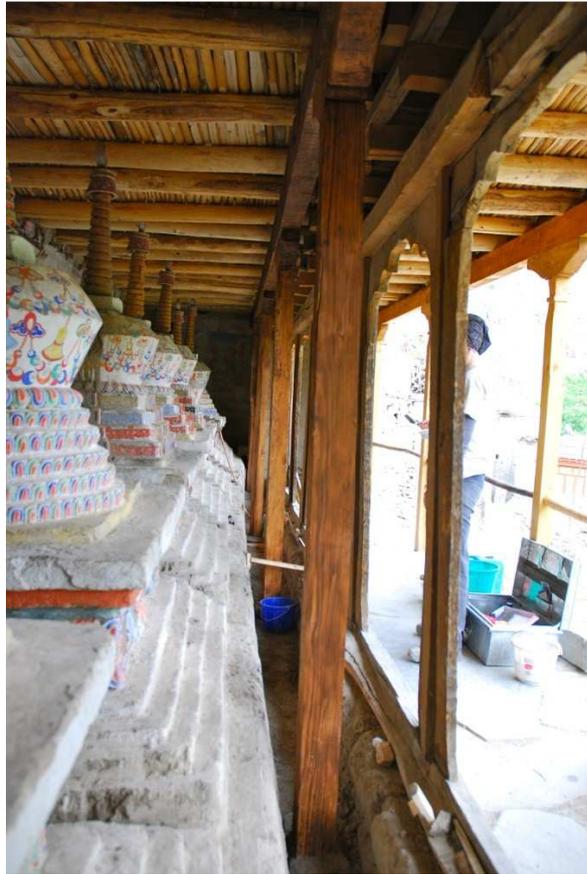
Fig. 87: Treatment of the new wooden structure behind the screen. (photo: Susanne Bosch)

The new wooden structure behind the wooden screen was protected with walnut shell stain (mixture of 1 spoon of burnt walnut shell on 1 litre of hot water). It was intended to take away the attention from the new structure by colouring it in a darker tone.

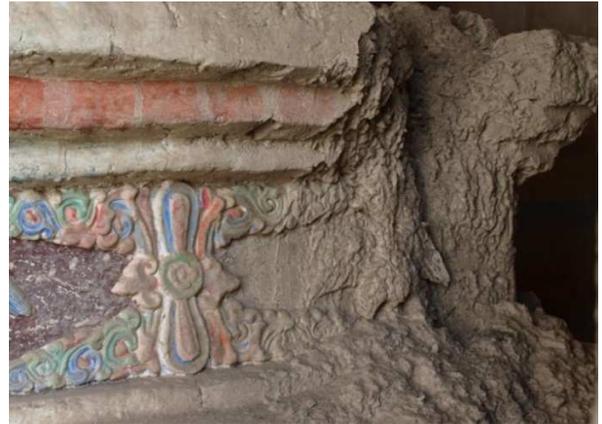
Fig. 2: Peacock, facing left, only dimly discernible; mostly washed away by water and covered in mud runners..

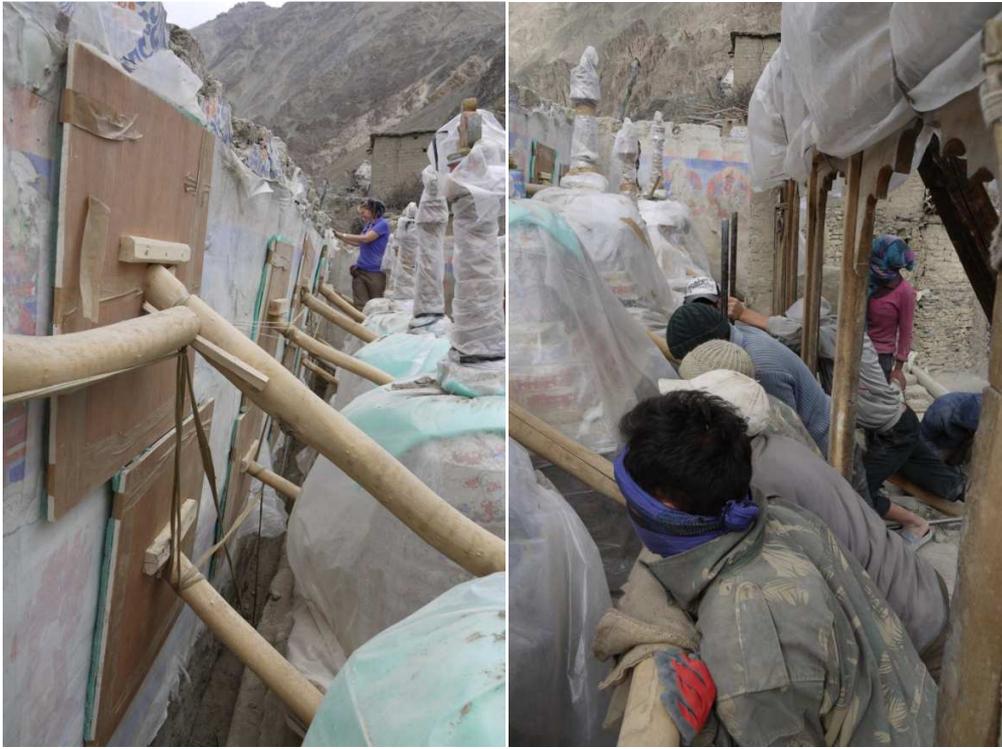
Fig. 109: Anne Voll checking the condition while pushing the wall. (photo: Hilde Vets)

Fig. 110: The men pushing the wall. (photo: Hilde Vets)

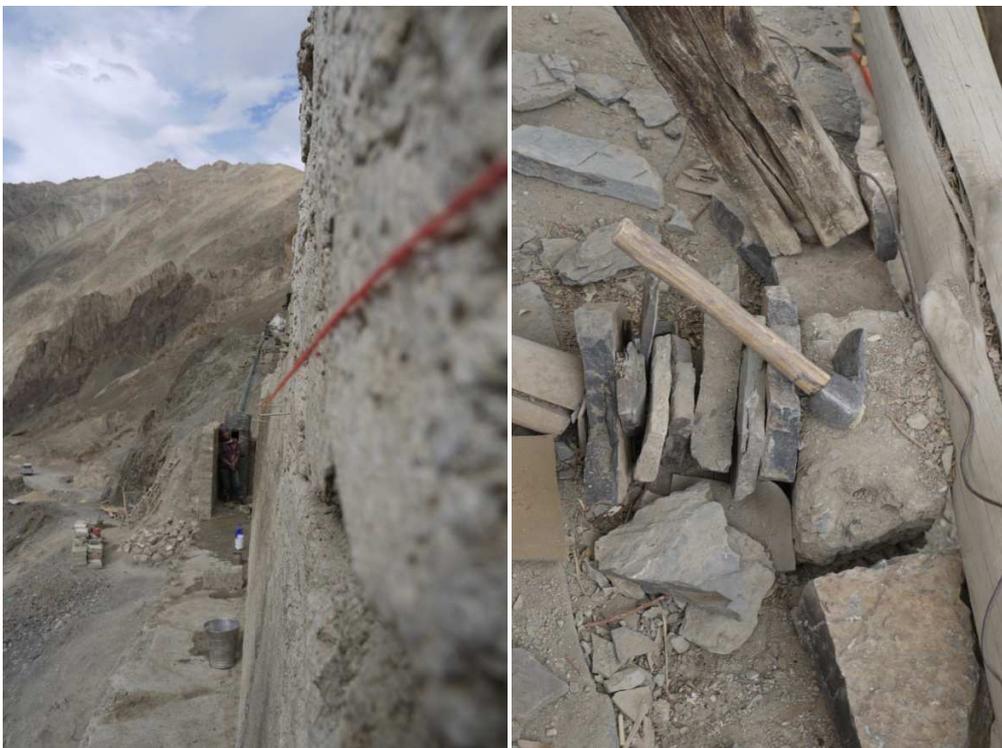
Fig. 111: Checking the inclination of the wall at the backside, during pushing. (photo: Hilde Vets)

Fig. 112: Stones put behind the props while pushing: max. of 30,5 cm. (photo: Hilde Vets)

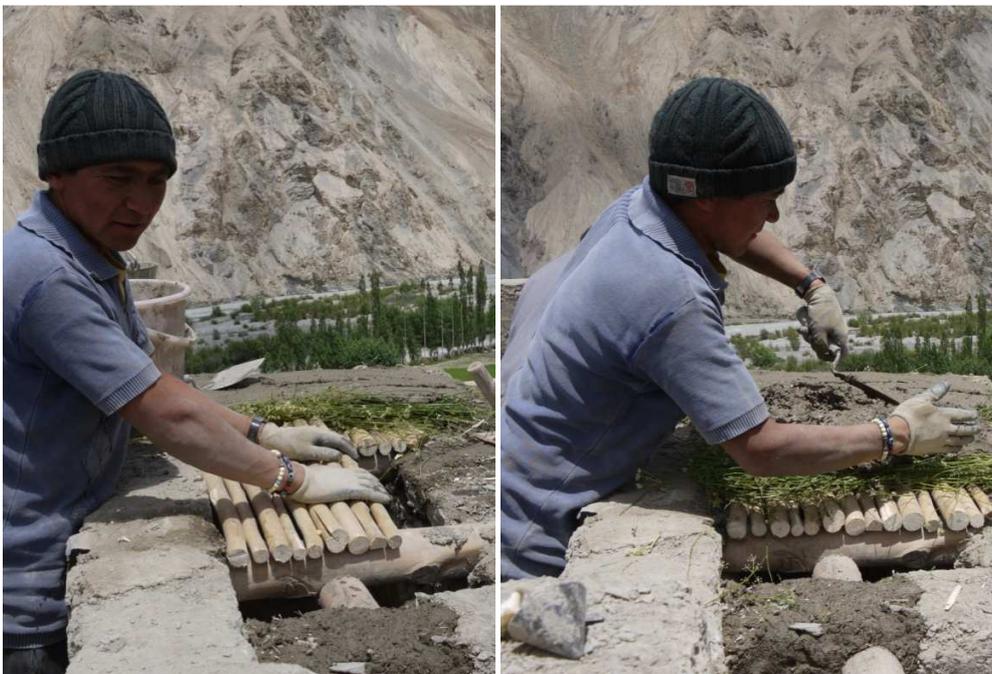
Fig. 115: Making the roof of the entrance niche: *talus* and *burtse* (photo: Hilde Vets)

Fig. 116: Making the roof of the entrance niche: fixing the *burtse* with mud mortar (photo: Hilde Vets)

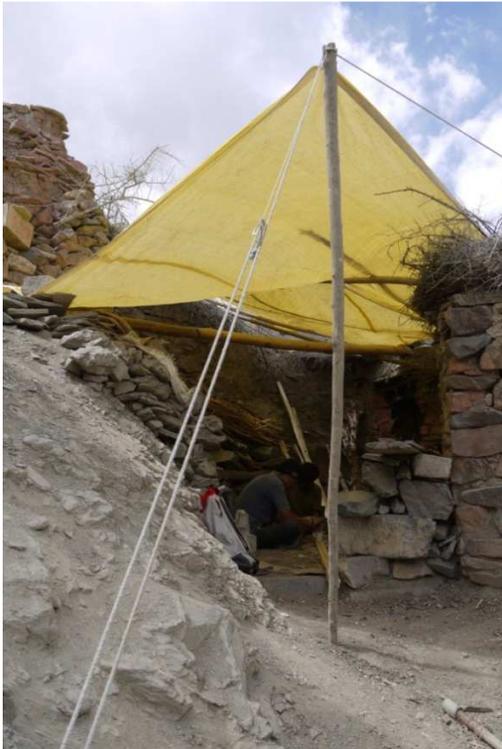
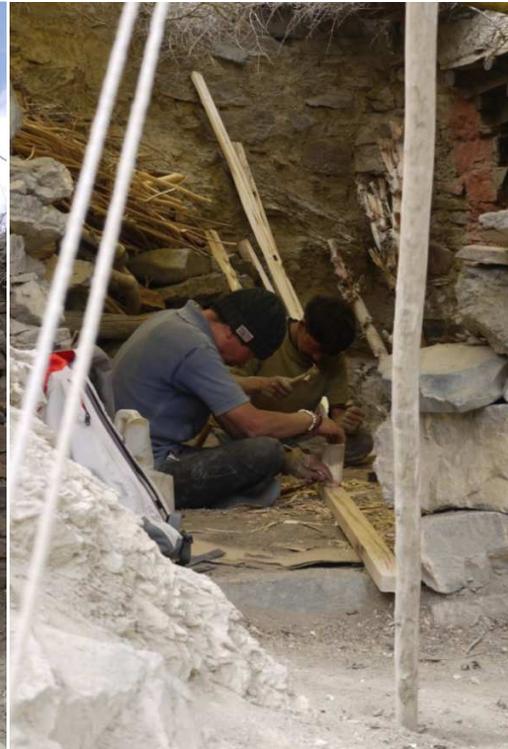
Fig. 117: The carpenter atelier. (photo: Hilde Vets)

Fig. 118: The carpenters making the *mutik shing* (photo: Hilde Vets)

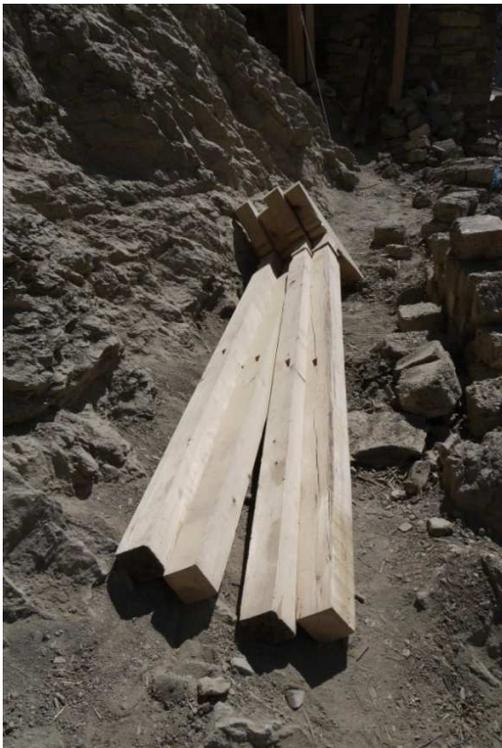
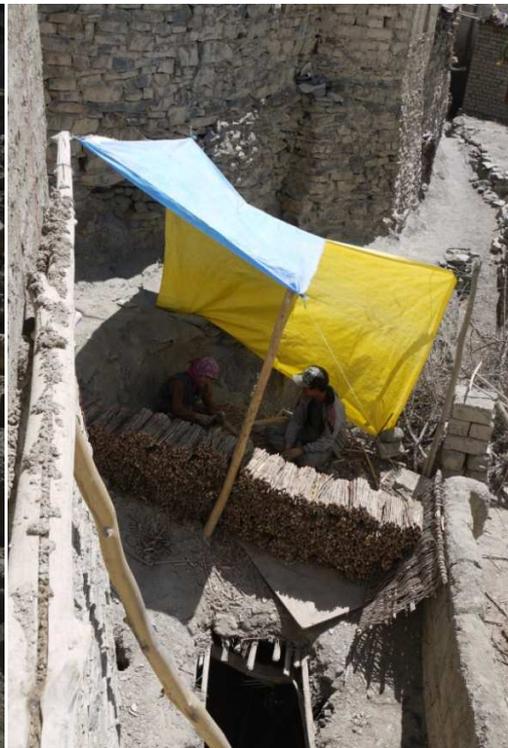
Fig. 119: Prepared columns and capitals for the new wooden structures(photo: Hilde Vets)

Fig. 120: Cutting and binding the *talu*, shaded under some plastic sheets. (photo: Hilde Vets)

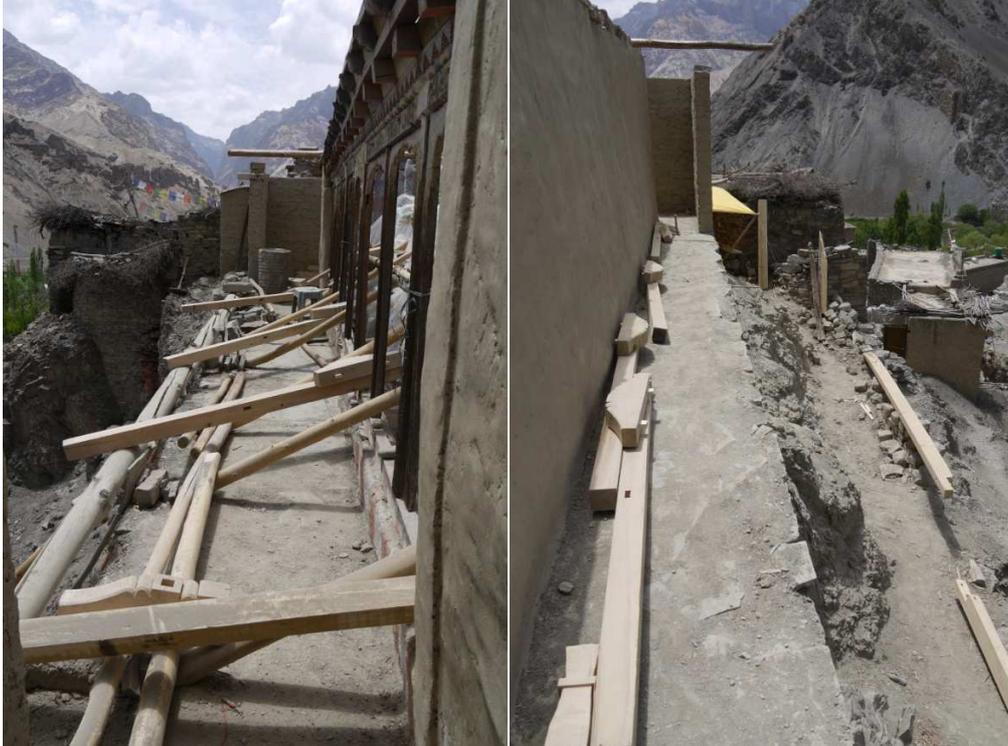
Fig. 121: The columns and capitals positioned at their respective places: south. (photo: Hilde Vets)

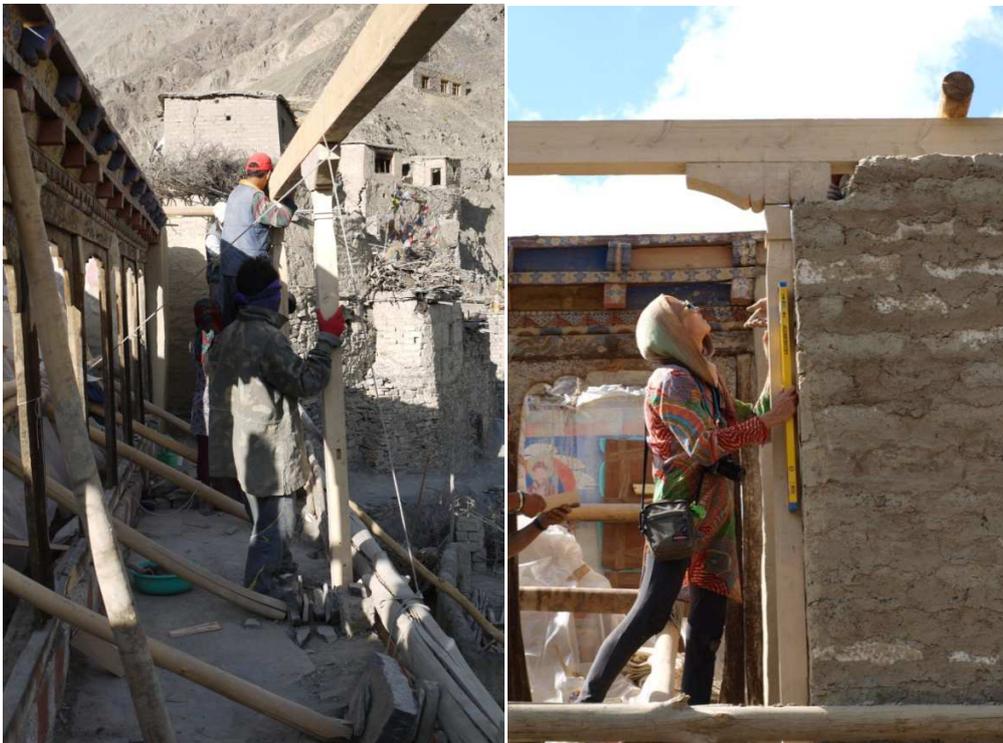
Fig. 123: Putting in the wooden structure at the south veranda. (photo: Hilde Vets)

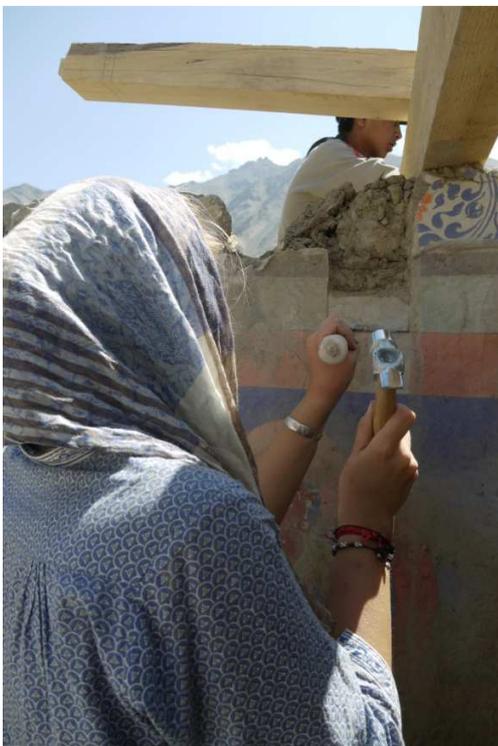
Fig. 127: Anne cutting out a rectangular piece of painting for the new beam (photo: Hilde Vets)

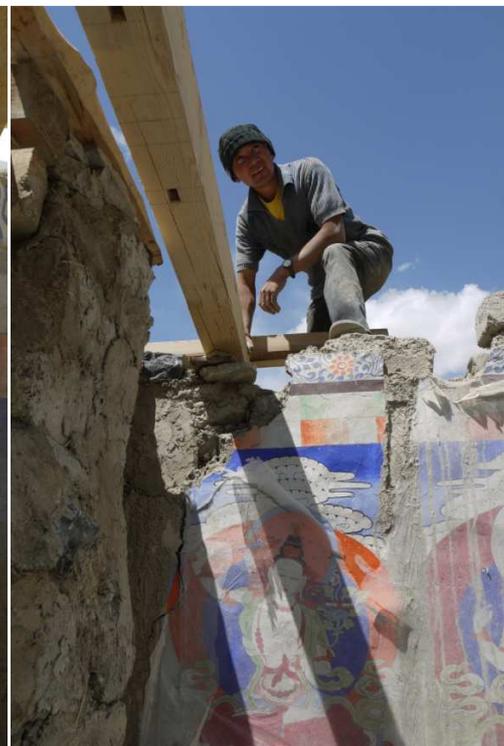
Fig. 128: West side where the new beam will be positioned. (photo: Hilde Vets)

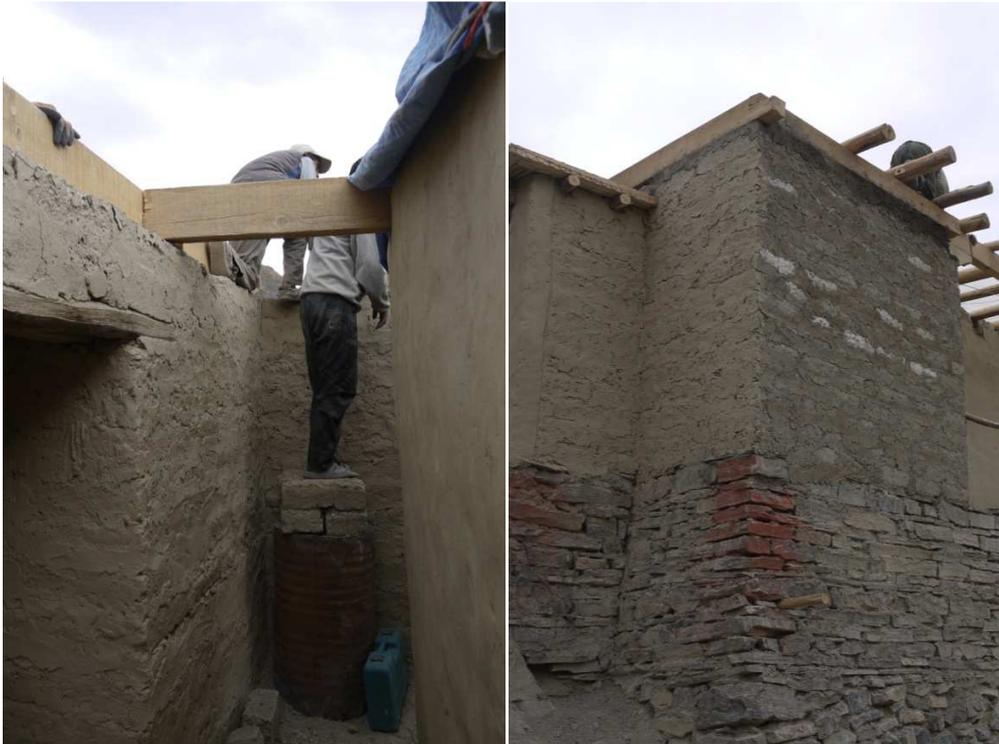
Fig. 129: The connection between the beam of the middle structure with the ring beam.

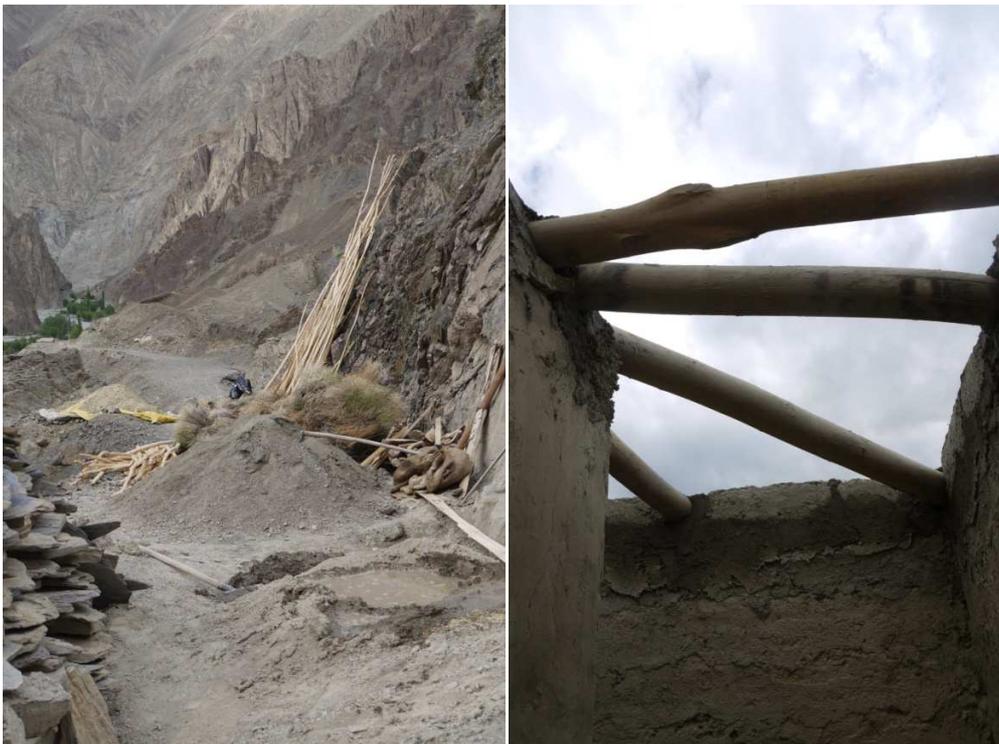
Fig. 131: The materials: *yamang*, sand, *pema*, *burtse*, *markalag*, *talu*. (photo: Hilde Vets)

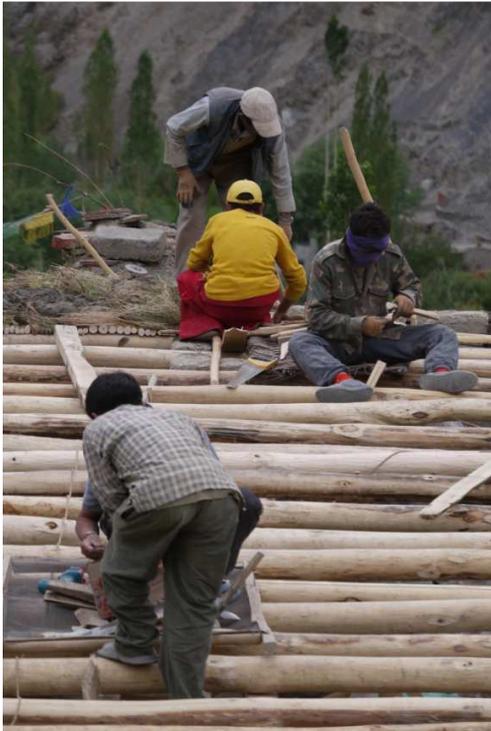
Fig. 133: Construction of the roof. (photo: Hilde Vets)

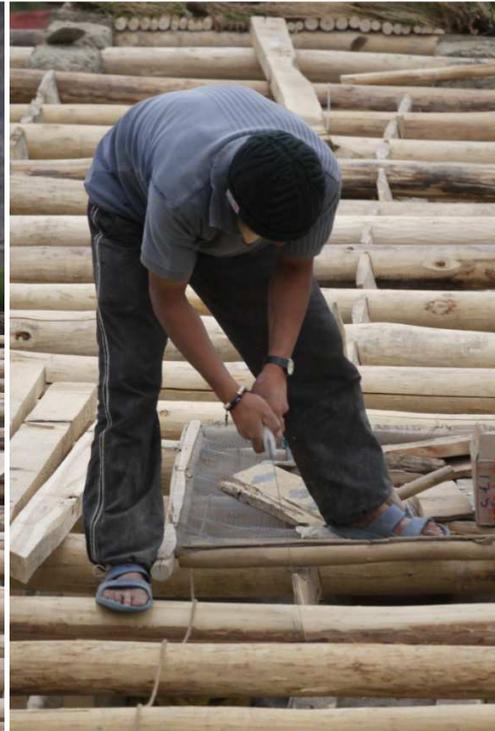
Fig. 134: Cutting grooves in the *dungma* for the boards or *spang-leb*. (photo: Hilde Vets)

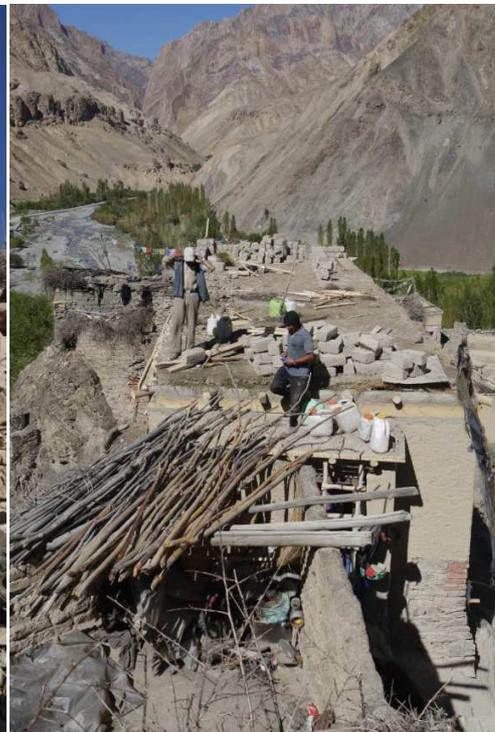
Fig. 136: The roof with first layer of mud and materials for parapets. (photo: Hilde Vets)

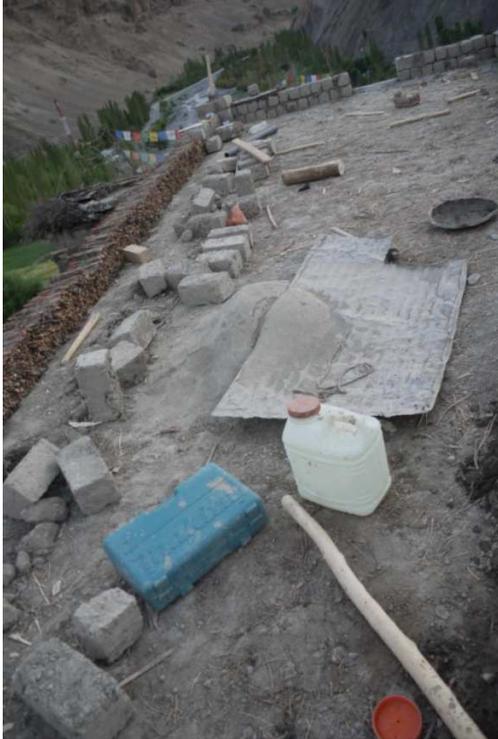
Fig. 137: Construction of the parapet with *talus* (*spedma*). (photo: Hilde Vets)

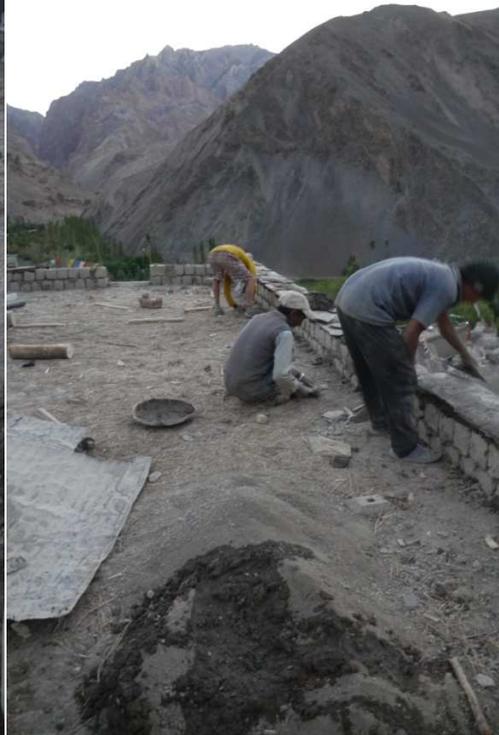
Fig. 138: construction of the parapet with small *phagbu*, *yamang*, mud mortar. (photo: Hilde Vets)
